TEST RESULTS

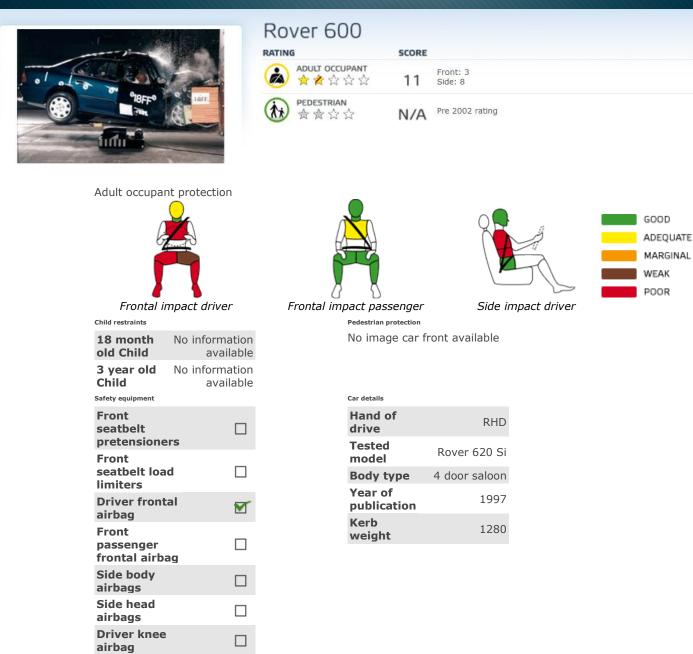
The 600's passenger compartment became structurally unstable during the frontal impact and the driver ran a high risk of life-threatening chest and abdominal injuries in the side impact. The distance by which the steering wheel was displaced backwards into the cabin during the front impact posed further risks of injury, while stiff structures in the lower facia around the knee impact area increased the likelihood of damage to the driver's knees, thighs and pelvis.

The driver's screen pillar was pushed backwards by 215mm (8.5in), the cabin became structurally unstable and the driver's door was severely damaged. This could not be opened by hand, and tools were needed to free it, although the passenger's door could be opened normally. The steering wheel was pushed backwards by 166mm (6.5in) and downwards by 63mm (2.5in). There was also excessive footwell intrusion, with the brake pedal displaced rearwards by 334mm (13.1in). Although head protection in the test was good, the amount that the steering wheel moved could have caused a hazard for shorter or taller drivers so the results were down-graded. The standard-fit airbag worked adequately and neck protection was generally good. The restraint system kept the driver's chest away from the steering wheel but forces transmitted to the chest via the seat belt posed a risk of injury, and the amount of facia intrusion might have made this worse for different-sized drivers. The driver's left knee struck the column cladding and then the facia. If his knee had been in a slightly different position horizontally at the moment of impact, the column adjuster could have been hit, adding to the likelihood of injury. A higher knee position could also have resulted in contact with this adjustment lever or the column support tube. Had the knee

penetrated the facia further, the risk of injury could have increased. In addition, the column adjustment lever, or the column shroud bracket could have caused localised damage to the knee. The driver's right knee scuffed the column shroud and struck the facia. Again, a slightly higher position at the moment of impact could have brought it into contact with the column support tube. If the knee had penetrated slightly further, the probability of injury could have increased still further. Structures present beneath the column cladding could also have worsened any injuries suffered. Lastly, excessive intrusion into the footwell resulted in poor foot and ankle protection. Protection for the front passenger was generally good, although forces transmitted to the chest via the seat belt presented a risk of injury, and there was also a similar risk level noted for the left lower leg.

The Rover 600 would have failed next year's side-impact legislation for newly launched models. Instrumentation attached to the dummy's ribs and abdomen gave high readings, indicating that protection for these vulnerable body regions was poor. Protection for the driver's head and pelvis was rated as good, though.

The adult belt's buckle and tongue would not tighten sufficiently to provide a good 'hold' on the child seat. Also, the child seat's front support bar rested on an unsupported part of the Rover's rear seat cushion. This would have compressed downwards during a frontal impact, permitting the child seat to move too far forwards. The front bar could even have slipped over the front edge of the car seat. In the frontal impact, both children in the Rover hit their heads on the front seats. The instrumented dummy experienced high head acceleration, indicating a considerable risk of serious head injury. Since these tests were carried out, Rover has changed the type of child restraint it recommends for use across the 600 model range.

Child head impact Four of the six test locations met proposed legislation: above the air filter housing, over a bonnet crease, over the high tension lead clip on the rocker cover and at one other point. One performed better than the group average and one was worse: over the highest point on the inner wing. Upper leg impact None of the three tests met proposed legislation and none were better than average. All three tests on the bonnet leading edge were worse than average. Adult head impact Only one test met proposed legislation: above a bonnet crease line. Two points were better than average: above a bonnet strengthener and over a wiper spindle. Three points were worse: above the bonnet hinge, on the rear lip of the bonnet and on a bonnet crease line. Leg impact None of the three tests met requirements and none were better than average. All three tests were worse.
