# **TEST RESULTS**

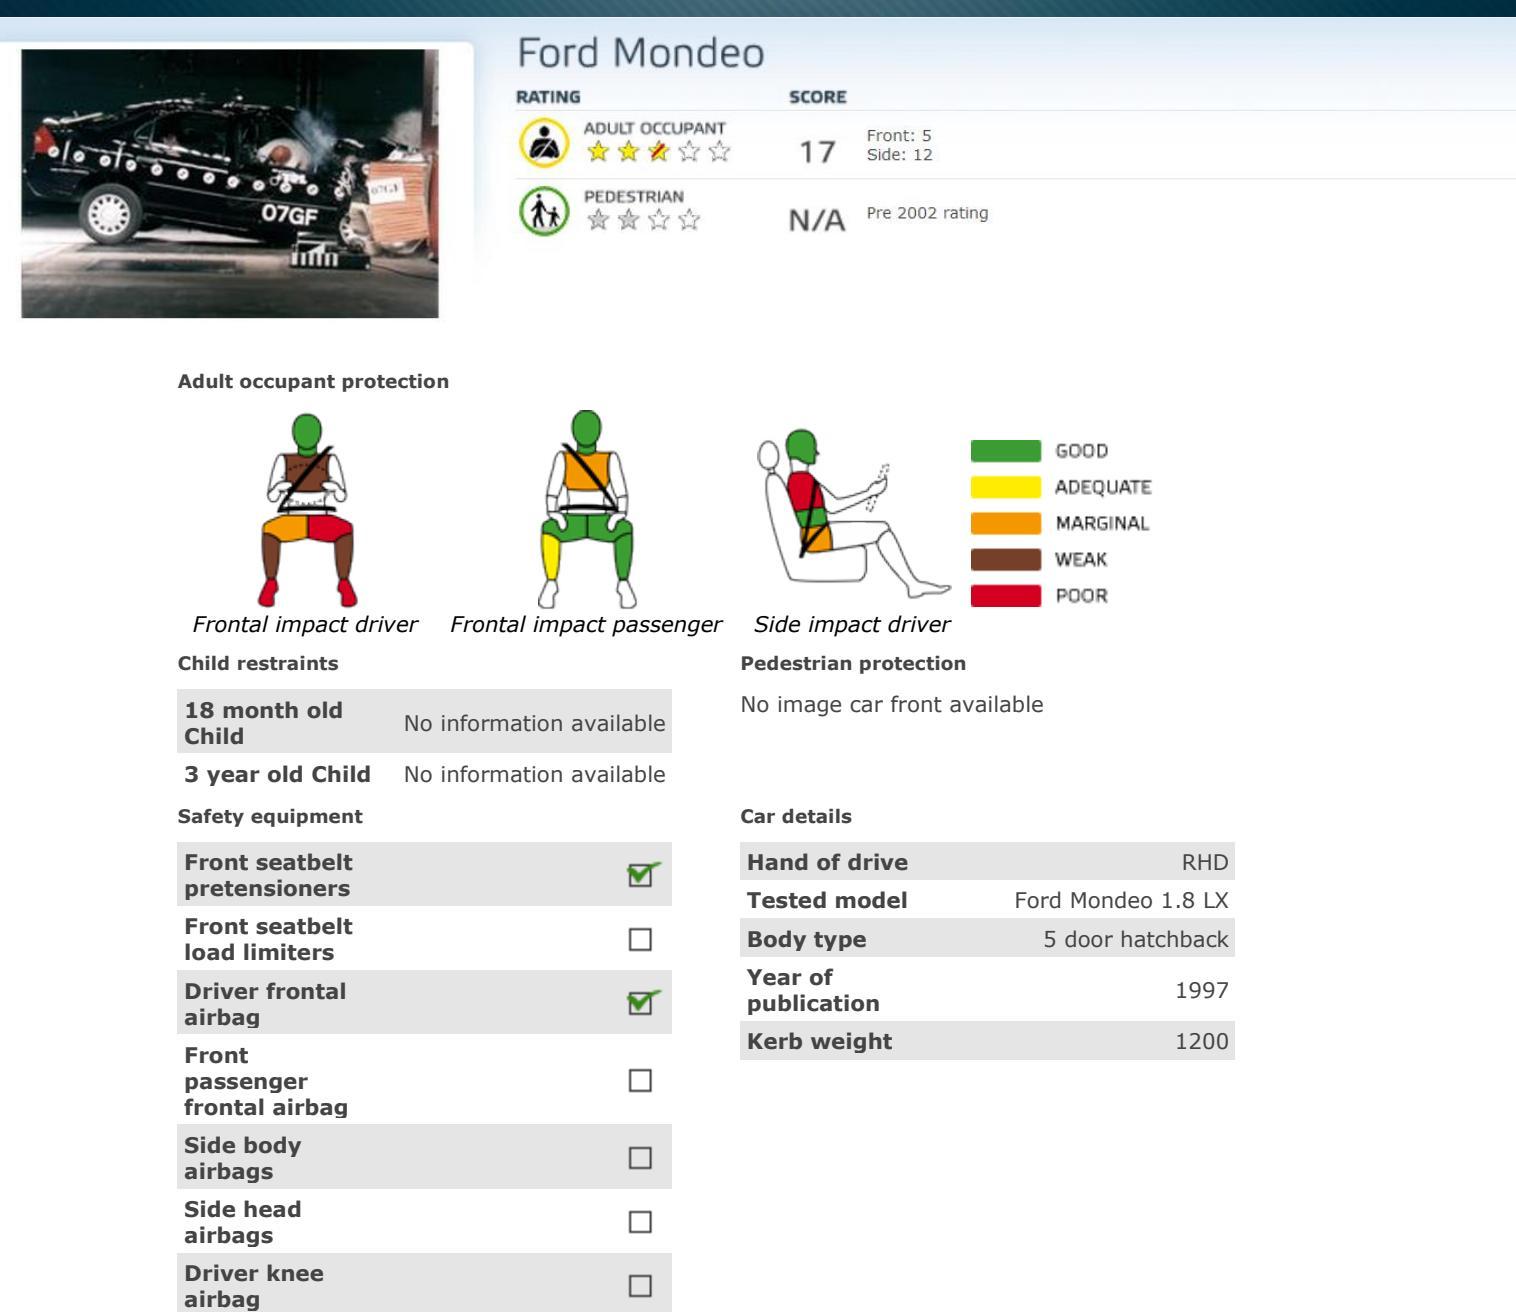
Although this top-selling family hatchback received a three-star rating for its overall performance, the results from the side-impact test failed to meet standards laid down for the crash testing of new models from next year. In the side-impact test, the loading on the dummy's chest meant poor protection for this body region. The driver's head, abdomen and pelvis were generally well protected. In the frontal-impact test, the metal beam supporting the facia and steering column broke away from its side mounting. The impact resulted in excessive footwell intrusion. The Mondeo was fitted with a standard driver airbag that provided good protection, and no contact between the driver's chest and the steering wheel was detected. Stiff structures present in the lower facia increased the likelihood in frontal impacts of injury to the driver's knees thighs and pelvis.

The driver's front screen pillar was pushed back by 70mm (2.8in). The beam supporting the facia and the steering column broke away and compromised the integrity of the passenger cabin. The driver's door had to be prised open, though the front passenger's door opened easily. The steering wheel was pushed back by 97mm (3.6in) and up by 52mm (2.0in) but the brake pedal was pushed backwards by 259mm (10.2in) and intrusion into the footwell was rated excessive. Protection for the head and neck was good, but protection for the chest was rated 'weak'. While the car's airbag and seat belt restrained the driver effectively, the way that the beam supporting the facia became detached posed a threat, and injury risks would have been even greater in slightly

different circumstances to those of the test. The impact meant that the driver's left knee hit the steering column adjustment lever, column shroud and facia, but if his knee had struck the facia in a slightly different position horizontally, it would have hit stiffer structures. The driver's right knee brushed the column shroud and hit the facia. But had it been in a slightly different horizontal position immediately prior to impact, it could have struck the steering column lock. Had either knee penetrated the facia further than they did, the risk of injury would have been increased. Concentrated loads could also cause localised damage to both knee. For these reasons, results gained from the test dummy were down-graded. Protection for both lower legs was assessed as weak, using data from the dummy alone, and an excessive amount of intrusion into the footwell meant that feet and ankle protection were rated as poor. In general, protection for the front passenger was good. The areas where concern was noted included the way the seat belt loaded the passenger's chest, and forces acting on the right lower leg. Protection for both feet and ankles was also assessed as good.

The Mondeo would have failed the side-impact legislation due to be applied to new models launched from next year. The reason for this was that high levels of loading from the car's side were measured by instrumentation attached to two of the dummy's ribs, indicating that protection for this body region was poor. However, the level of protection that the Ford Mondeo provided for the driver's head, abdomen and pelvis in the side impact was rated as good in each case.

Child head impact Two of the six locations met proposed legislation: one above the oil filler cap, the other above a bonnet strengthener. Three points were better than average, one worse: at the bonnet/wing join. Upper leg impact None of the three tests met proposed legislation and all three tests were worse than average: on the bonnet leading edge at the centre-line of the car, in line with the towing eye mount, and in line with the headlight's inboard edge. Adult head impact None of the tests met proposed legislation. Four points were better than average, two were worse: above the bonnet hinge and over the wiper spindle. Leg impact None of the three tests met the proposed requirements. Two points were better than average – at the inboard edge of the headlight and at the car's centre-line. One was worse: in line with the towing eye bracket.
