Opel/Vauxhall Karl
Standard Safety Equipment

2017

Tested Model	Opel Karl 1.0 'Enjoy', LHD
Body Type	- 5 door hatchback
Year Of Publication	2017
Kerb Weight	920kg
VIN From Which Rating Applies	- all Karls
Class	Supermini

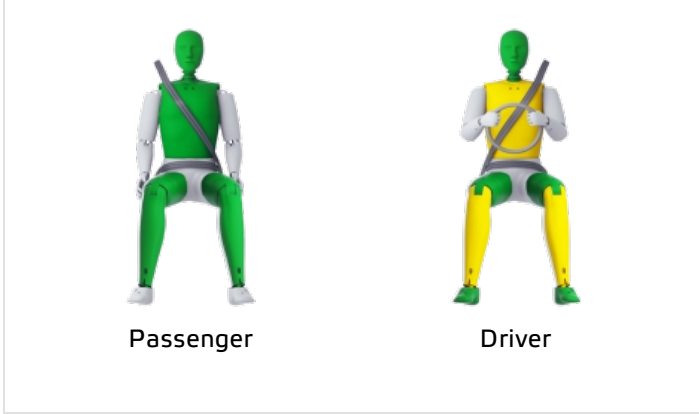
Frontal Offset Deformable Barrier 7.4 Pts

Passenger Driver

Detailed description: This panel shows two crash test dummies. The Passenger dummy is green, indicating a 'GOOD' result. The Driver dummy is yellow, indicating an 'ADEQUATE' result.

The passenger compartment of the Karl remained stable in the frontal offset test. Dummy readings indicated good protection of the knees and femurs of the driver and passenger. Opel showed that a similar level of protection would be provided to occupants of different sizes and to those sat in different positions. In the full-width rigid barrier test, the pelvis of the rear passenger dummy slipped beneath the lap portion of the seatbelt, and protection of this body area was rated as poor. Protection of the chest was rated as marginal, based on dummy readings of chest compression. Protection of all critical body areas was good for the driver dummy. In the side barrier test, protection of all critical parts of the body was good and the Karl scored maximum points. However, in the more severe side pole impact, the head 'bottomed out' the curtain airbag and the resulting high decelerations indicated poor protection of this body area. Chest protection was rated as marginal based on dummy readings of rib compression. Tests on the front seats and head restraints demonstrated marginal protection against whiplash injury in the event of a rear-end collision. A geometric assessment of the rear seats also indicated marginal whiplash protection.

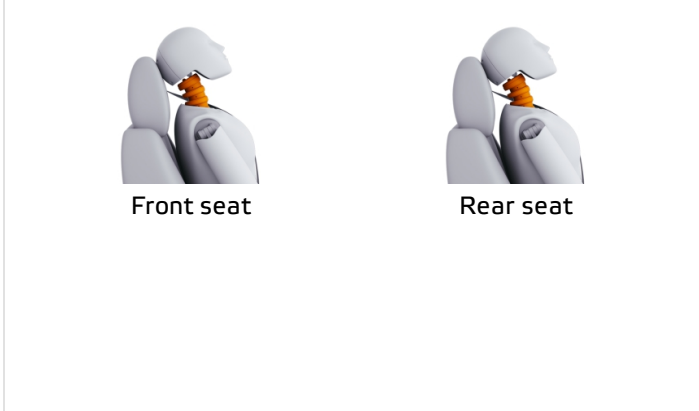
Whiplash Rear Impact 1.6 Pts

Front seat Rear seat

Detailed description: This panel shows two views of a car seat headrest. The front seat view shows a green neck area, indicating 'GOOD'. The rear seat view shows an orange neck area, indicating 'MARGINAL'.

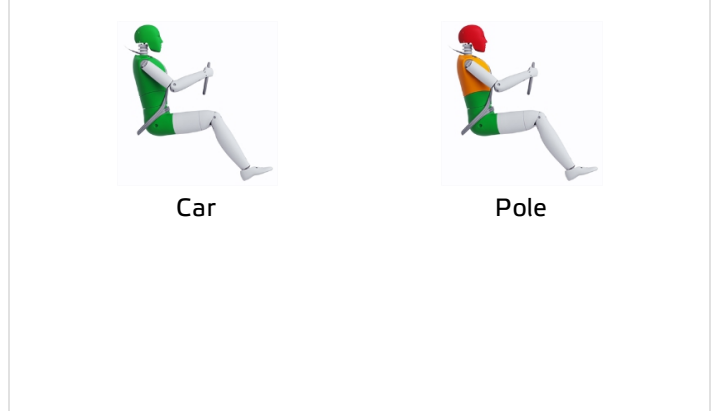
Lateral Impact 8 Pts

Car Pole

Detailed description: This panel shows two side-impact crash test scenarios. The 'Car' scenario shows a green dummy, indicating 'GOOD'. The 'Pole' scenario shows a red dummy, indicating 'POOR'.
