Toyota Proace
Business and Family Van

2015

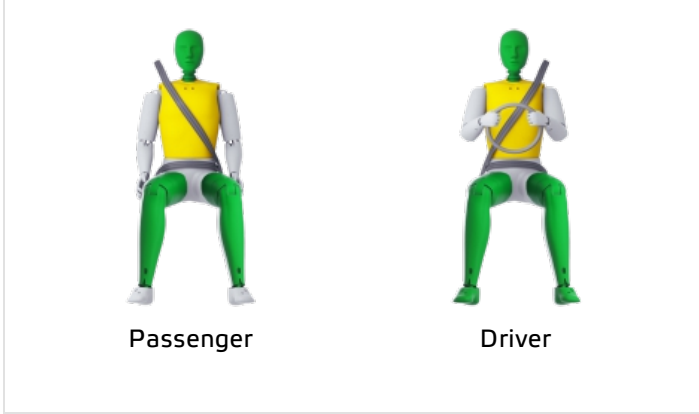
Frontal Offset Deformable Barrier 15.3 Pts

Passenger Driver

Detailed description: This panel shows the results for the Frontal Offset Deformable Barrier test. It features two side-view illustrations of a crash test dummy. The dummy on the left is labeled 'Passenger' and is wearing a yellow vest and green pants. The dummy on the right is labeled 'Driver' and is wearing a yellow vest and green pants. Both dummies are shown in a seated position, facing forward, with their arms and legs positioned as if they were in a car seat. The background is white.

The passenger compartment remained stable in the frontal impact. Dummy readings indicated good protection of the knees and femurs of the driver and passenger. Toyota showed that a similar level of safety would be available to occupants of different sizes and to those sat in different positions. Currently, the full width rigid barrier test is not done on vehicles in the Business and Family Van category. In the side barrier test, the Proace scored maximum points, with good protection of all body areas. In the more severe side pole impact, dummy readings of rib compression indicated marginal chest protection but the protection of other body areas was rated as good. A geometric assessment indicated good whiplash protection for the front seat occupants but poor whiplash protection for those in the rear.

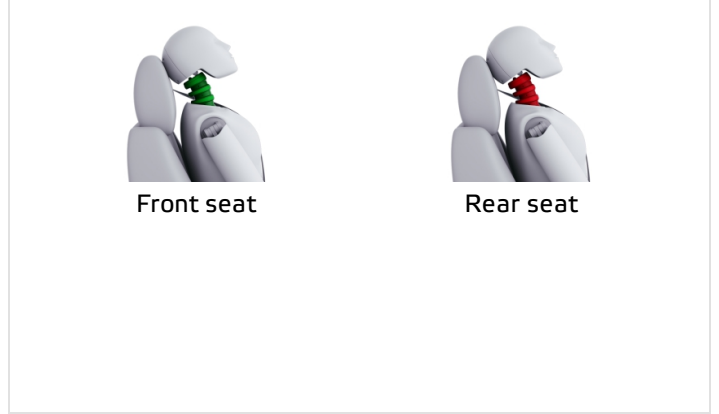
Whiplash Rear Impact 1.6 Pts

Front seat Rear seat

Detailed description: This panel shows the results for the Whiplash Rear Impact test. It features two side-view illustrations of a crash test dummy's head and neck. The dummy on the left is labeled 'Front seat' and has a green neck. The dummy on the right is labeled 'Rear seat' and has a red neck. Both dummies are shown in a seated position, facing forward, with their heads tilted back. The background is white.

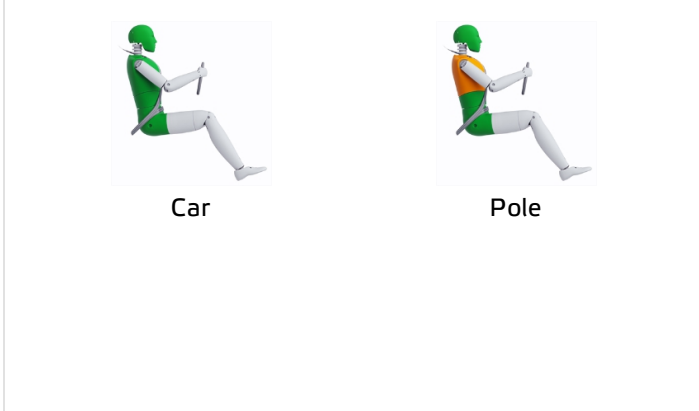
Lateral Impact 14.7 Pts

Car Pole

Detailed description: This panel shows the results for the Lateral Impact test. It features two side-view illustrations of a crash test dummy. The dummy on the left is labeled 'Car' and is wearing a green vest and green pants. The dummy on the right is labeled 'Pole' and is wearing an orange vest and green pants. Both dummies are shown in a seated position, facing forward, with their arms and legs positioned as if they were in a car seat. The background is white.
