Peugeot Traveller
Business and Family Van

2015 ★★★★★

SPECIFICATION

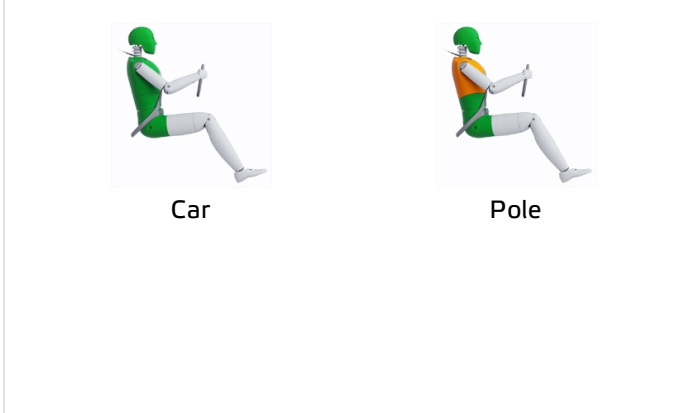
Lateral Impact 14.7 Pts

Car Pole

Detailed description: This panel shows the results for the Lateral Impact test. It features two side-view illustrations of a crash test dummy. The dummy on the left is labeled 'Car' and is wearing a green vest and white pants. The dummy on the right is labeled 'Pole' and is wearing an orange vest and white pants. Both dummies are shown in a seated position with their seatbelts fastened. The background is white.

The passenger compartment remained stable in the frontal impact. Dummy readings indicated good protection of the knees and femurs of the driver and passenger. Peugeot showed that a similar level of safety would be available to occupants of different sizes and to those sat in different positions. Currently, the full width rigid barrier test is not done on vehicles in the Business and Family Van category. In the side barrier test, the Traveller scored maximum points, with good protection of all body areas. In the more severe side pole impact, dummy readings of rib compression indicated marginal chest protection but the protection of other body areas was rated as good. A geometric assessment indicated good whiplash protection for the front seat occupants but poor whiplash protection for those in the rear.
