Peugeot 3008/5008
Standard Safety Equipment

2016 ★★★★★

Tested Model	Peugeot 3008 1,6l Hdi Active
Body Type	- 5 door SUV
Year Of Publication	2016
Kerb Weight	1300kg
VIN From Which Rating Applies	- all 3008s and 5008s
Class	Small Off-Road

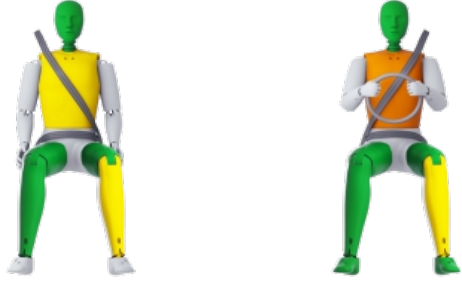
Frontal Offset Deformable Barrier 7 Pts

The passenger compartment of the 3008 remained stable in the offset frontal impact test. Dummy readings of chest compression revealed marginal protection of the driver's chest. Good protection was seen for the knees and femurs of both the driver and passenger. Peugeot demonstrated that a similar level of protection would be provided to occupants of different sizes and to those sat in different positions. In the full-width rigid barrier test, protection was good for critical body areas except the neck for the rear passenger and the chest and neck for the driver, protection of which was adequate. In the side barrier test, the 3008 scored maximum points with good protection of all critical body regions. In the more severe side pole impact, the chest was adequately protected and all other body areas were well protected. Tests on the front seats and head restraints showed good protection against whiplash injury in the event of a rear-end collision and a geometric assessment of the rear seats indicated the same level of protection there. In the 5008, the third row seats did not pass the whiplash assessment. For this car, the score for adult occupant protection is reduced from 86 percent to 85 percent but the star rating is unaffected. Some grades of the 3008 are equipped with an autonomous emergency braking system which would further protect against whiplash injury. Tests showed good performance but, as the system is not standard across the model range, its results are not included in this assessment.

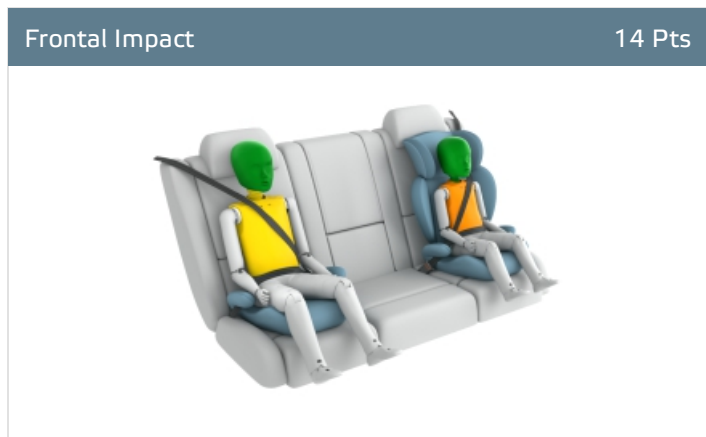
Crash Test Performance based on 6 & 10 year old children

Restraint for 6 year old child: *ROMER kidfix XP*
 Restraint for 10 year old child: *GRACO Boster*
 Safety Features

In the offset frontal impact, protection of the 10 year dummy's chest and neck was adequate and that of the head was good. Dummy readings of chest deceleration indicated marginal protection of the 6 year old's chest, with good protection of the head and neck. The 3008 provided good protection to all critical body areas of both dummies in the side barrier test. The front passenger airbag can be disabled to allow a rearward-facing child restraint to be used in that seating position. Clear information is provided regarding the status of the airbag and the system was rewarded. All of the child restraint types for which the 3008 is designed could be properly installed and accommodated in the vehicle. A check of the 5008 showed that all suitable restraints could be properly installed there also, and the score for child occupant protection is the same as the 3008.
