ACCELERATION PULSES AND CRASH SEVERITY IN LOW VELOCITY REAR IMPACTS – REAL WORLD DATA AND BARRIER TESTS

Chalmers University of Technology
Sweden
Paper Number 216

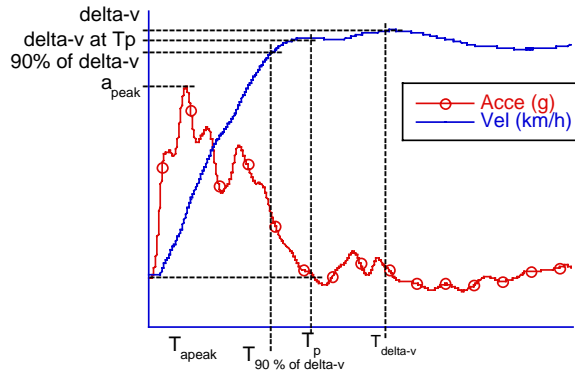
Figure 1. A Schematic drawing showing how a_{peak} , delta-v, 90% of delta-v, the time for these events and the duration of the acceleration pulse were identified from the graphs.

The T_p was measured when the acceleration changed from positive to negative after 90% of delta-v had occurred. To quantify the loads transferred at the impact, the mean acceleration of the crash pulse, a_{mean} , was calculated by dividing the delta-v at T_p by T_p . The time at which 90% of the maximum delta-v was achieved was calculated, in order to estimate how rapidly the main part of the energy was transferred into the impacted vehicle.

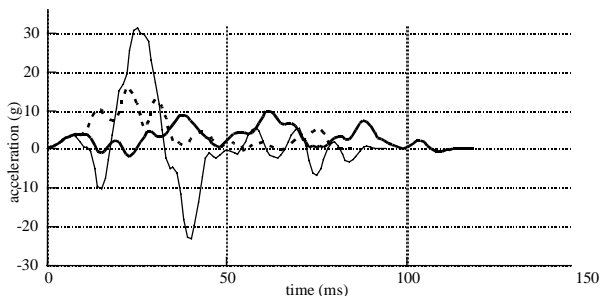
Figure 3. The acceleration pulse measured in car A in three different collisions.

Figures 3 and 4 show the three different acceleration pulses from the real-world impacts. Two different car models were used (3 of each). Table 7 shows the great variation of the peak acceleration, the mean acceleration and the delta-v for the two different cars. The duration of the pulses ranged from 75 ms - 135 ms. Figure 3 shows the acceleration pulses recorded in car A causing a change of velocity between 10.1-12.7 km/h a mean acceleration from 3.4 g - 8.5 g and a peak acceleration from 9.9 g - 31.3 g. Figure 4 shows the acceleration pulse recorded in car B causing a change of velocity between 10.7 km/h and 12.3 km/h, a mean acceleration from 2.9 g - 4.0 g and a peak acceleration from 5.3 g - 11.2 g.

Further barrier tests would need to be undertaken to investigate if the findings of this study will be repeated at higher impact velocities with differing degrees of structural engagement and overlap. The real-world crash pulses were collected from two car models and there is a considerable difference between the pulses both in terms of peak and mean acceleration (Figure 3

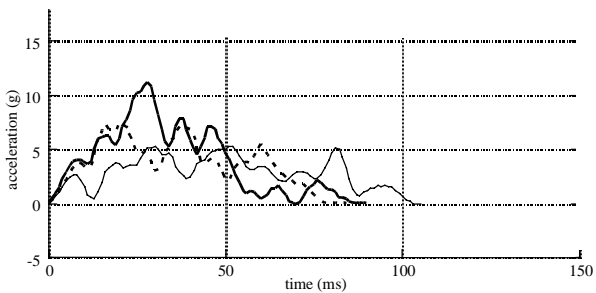
Figure 4. The acceleration pulse measured in car B in three different collisions.

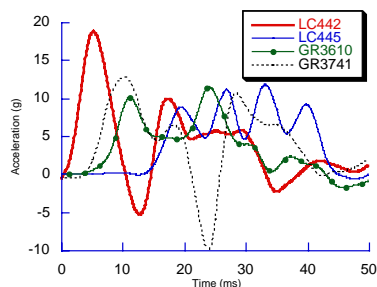
Figure 5. The crash pulses cars built with good low speed crash performances at 40% overlap at impact velocity of 15 km/h.

The vehicles tested for their damagability characteristics date from 1997 (LC422) to 2001 (GR3741) and are listed in chronological order. There is a large difference in the structural deformation characteristics of these vehicles. The best performers were those which had minor deformation and therefore correspondingly low repair costs. Several vehicles listed had a very good low speed crash performance (LC442, LC445, OW3610, GR3741) but correspondingly had the highest peak g (Figure 5).

Therefore, it can be assumed that those vehicles which perform well in this damagability test will impart a higher acceleration onto their respective occupants than those vehicles that have higher deformation but lower

peak acceleration values. Vehicles that perform well in a low-speed damagability crash test are often those which appear to have very stiff structures, i.e. the acceleration pulse that is produced tends to be shorter and of a higher magnitude. The use of a solid mobile barrier in the rear damagability crash test leads to very uniform engagement of stiff vehicle structure. However, in real-world crashes it is not uncommon to see vehicle structures fail to engage due to override or underide. This ‘mis-engagement’ leads to a softer pulse than is necessarily seen in the solid barrier test.

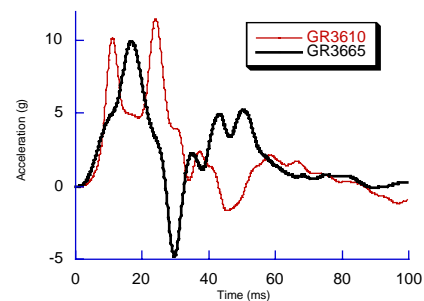
Figure 6. The crash pulses from two different cars built on the same platform at 40% overlap at impact velocity of 15 km/h.

A comparison between different cars built on the same platform was made (Figure 6).

In this comparison it was also found that large differences can be seen between cars built on the same platform. The GR3665 produces a rapid change in

acceleration from 10 g to -5 g and a different pulse shape than GR3610.

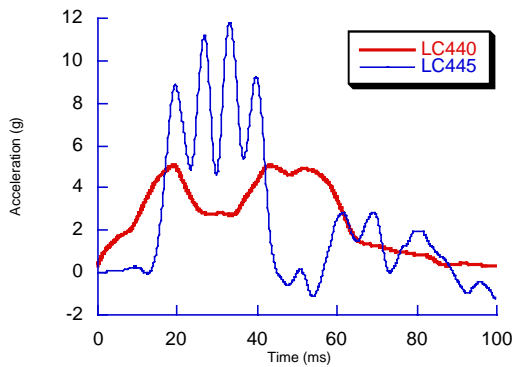
Figure A1. The acceleration pulse measured at the bottom of the B-pillar in the 40% overlap barrier test producing a delta-v of 8.9 km/h and 9.1 km/h.

The acceleration pulses are presented in the appendix in groups of similar vehicle weights and delta-v (Figure A1-A17). In some groups all the acceleration profiles are similar in shape (e.g. Figure A4 and A9) but in other groups the profiles vary considerably (Figure A1 and A16).

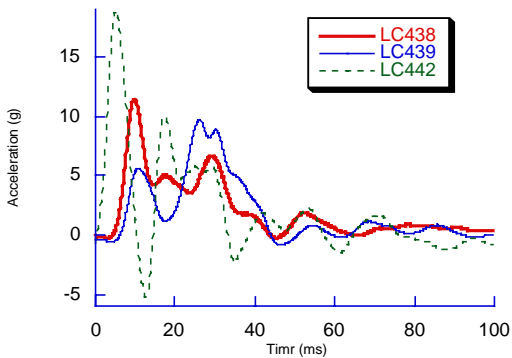
Figure A2. The acceleration pulse measured at the bottom of the B-pillar in the 40% overlap barrier test producing a delta-v between 6.6 km/h and 7.4 km/h.

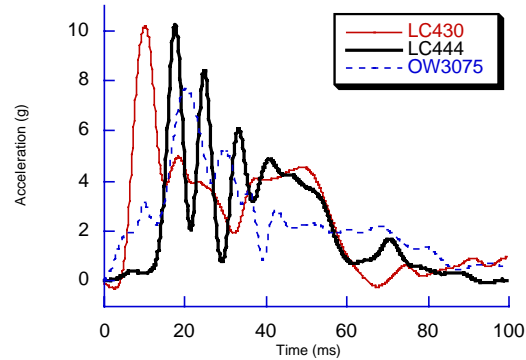
Figure A3. The acceleration pulse measured at the bottom of the B-pillar in the 40% overlap barrier test producing a delta-v between 7.9 km/h and 8.9 km/h.

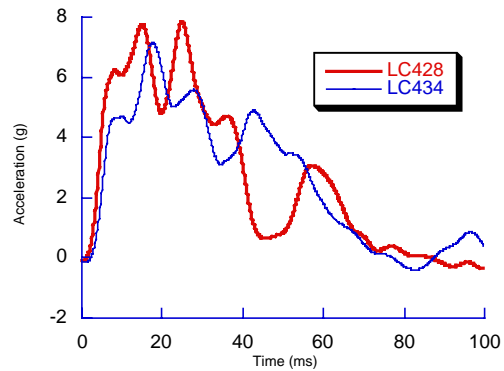
Figure A4. The acceleration pulse measured at the bottom at the B-pillar of the 40% overlap barrier test producing a delta-v of 9.3 km/h.

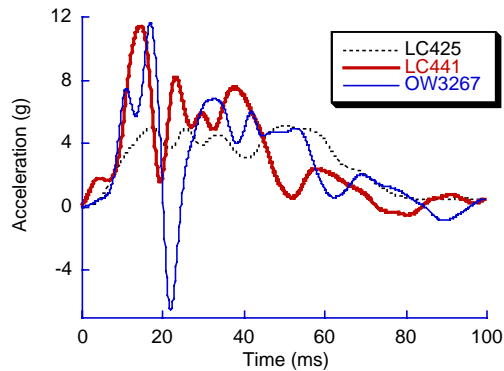
Figure A5. The acceleration pulse measured at the bottom of the B-pillar in the 40% overlap barrier test producing a delta-v between 9.4 km/h and 11.0 km/h.

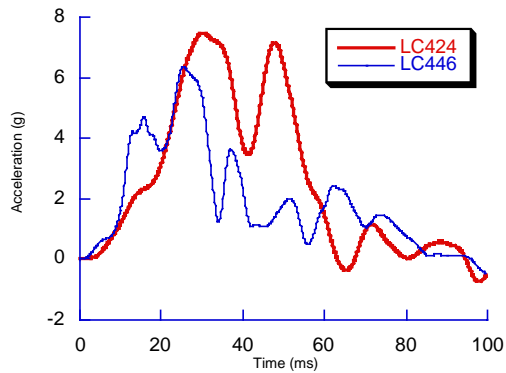
Figure A6. The acceleration pulse measured at the bottom of the B-pillar in the 40% overlap barrier test producing a delta-v of 8.2 km/h and 9.0 km/h.

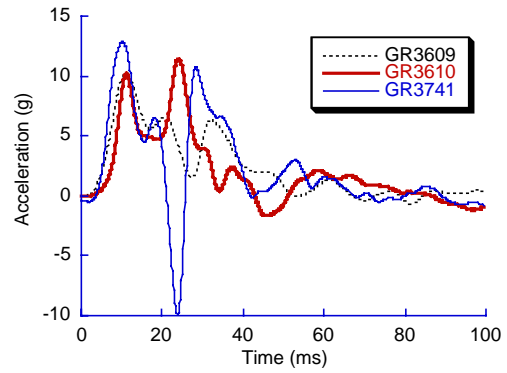
Figure A9. The acceleration pulse measured at the bottom of the B-pillar in the 40% overlap barrier test producing a delta-v between 7.2 km/h and 8.0 km/h.

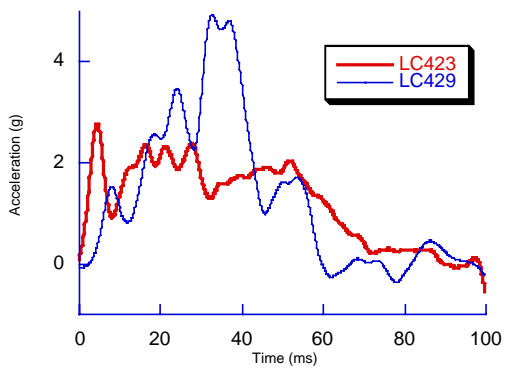
Figure A7. The acceleration pulse measured at the bottom of the B-pillar in the 40% overlap barrier test producing a delta-v of 4.3 km/h and 4.5 km/h.

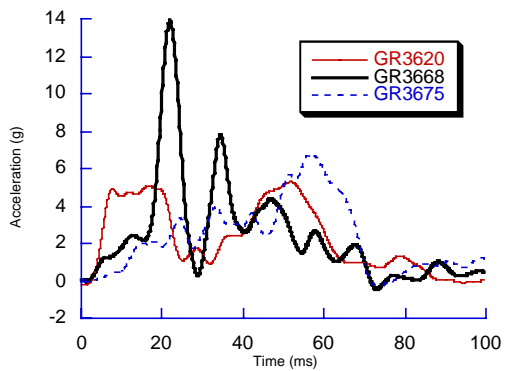
Figure A10. The acceleration pulse measured at the bottom of the B-pillar in the 40% overlap barrier test producing a delta-v between 6.9 km/h and 8.3 km/h.

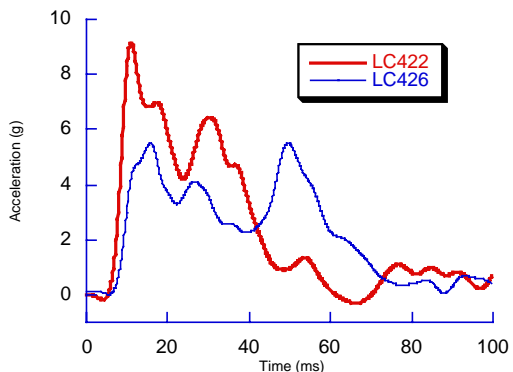
Figure A8. The acceleration pulse measured at the bottom of the B-pillar in the 40% overlap barrier test producing a delta-v of 8.0 km/h and 8.3 km/h.

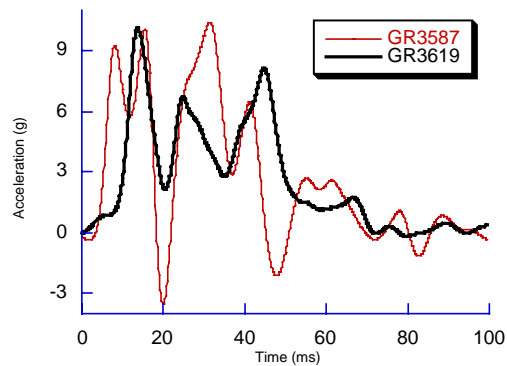
Figure A11. The acceleration pulse measured at the bottom of the B-pillar in the 40% overlap barrier test producing a delta-v of 9.0 km/h and 9.1 km/h.

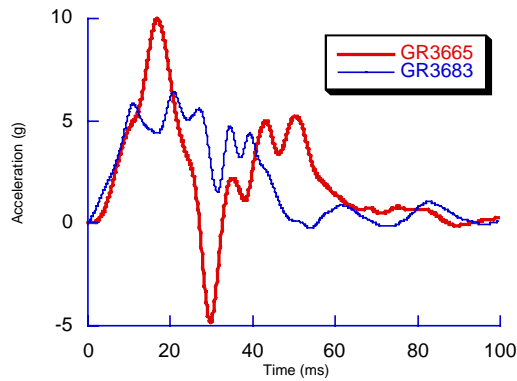
Figure A12. The acceleration pulse measured at the bottom of the B-pillar in the 40% overlap barrier test producing a delta-v of 7.8 km/h and 8.5 km/h.

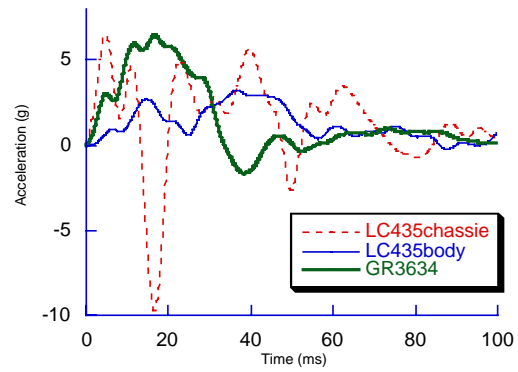
Figure A15. The acceleration pulse measured at the chassi and body in the 40% overlap barrier test producing a delta-v between 4.5 km/h and 5.4 km/h.

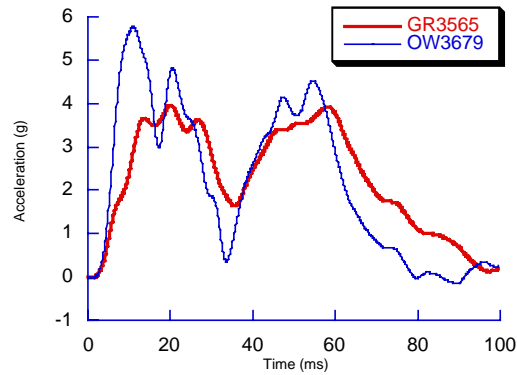
Figure A13. The acceleration pulse measured at the bottom of the B-pillar in the 40% overlap barrier test producing a delta-v of 8.0 km/h and 8.2 km/h

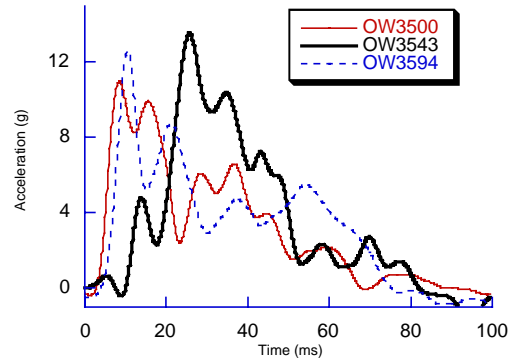
Figure A16. The acceleration pulse measured at the bottom of the B-pillar in the 100% overlap barrier test producing a delta-v between 11.0 km/h and 12.4 km/h.

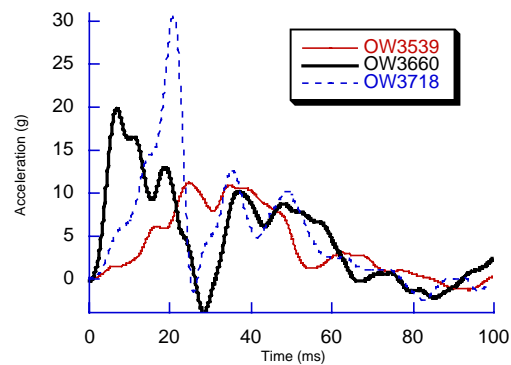
Figure A17. The acceleration pulse measured at the bottom of the B-pillar in the 100% overlap barrier test producing a delta-v between 14.0 km/h and 18.8 km/h.
