# VW T5

Volkswagen T5 Transporter Kombi

2013

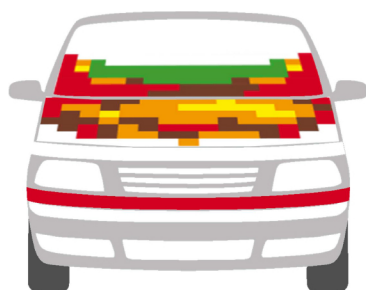
GOOD  
 ADEQUATE  
 MARGINAL  
 WEAK  
 POOR

HEAD 9,8 pts  
 PELVIS 0 pts  
 LEG 0 pts

The bumper provided poor protection to pedestrians' legs and scored no points in this area. Most of the bonnet surface provided protection that ranged between poor and marginal though good results were recorded on the windscreen.
