**Mobilize Limo**  
Standard Safety Equipment

2022

Tested Model	Mobilize Limo 'Techo', LHD
Body Type	- 5 door hatchback
Year Of Publication	2022
Kerb Weight	1600kg
VIN From Which Rating Applies	- all Limos
Class	Small Family Car

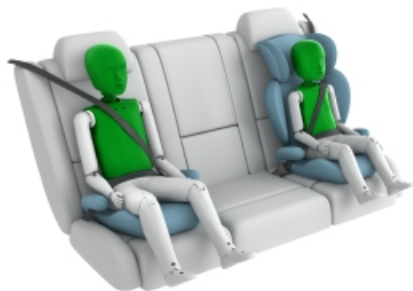
## Frontal Impact

16 Pts

Dummy readings indicated good protection of both the 6 and 10 year dummies in both the frontal offset and the side barrier tests. However, the 6 year dummy was not fully restrained in the side impact, and the Limo lost points in this part of the assessment. The front passenger airbag can be disabled to allow a rearward-facing child restraint to be used in that seating position. However, the labelling of the switch does not meet Euro NCAP's requirements for permanency. All of the restraint types for which the Limo is designed could be properly installed and accommodated.

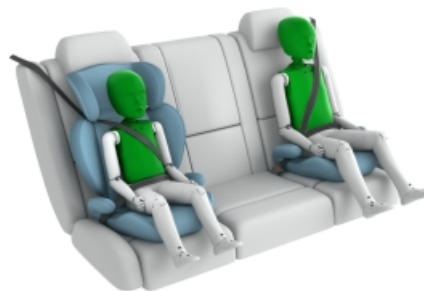
## Lateral Impact

4 Pts

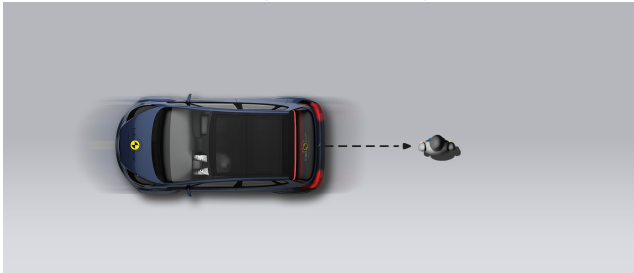
Vehicle reversing into standing pedestrian

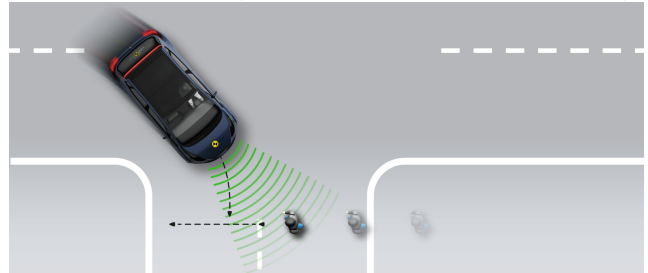
Pedestrian crossing a road into which a car is turning

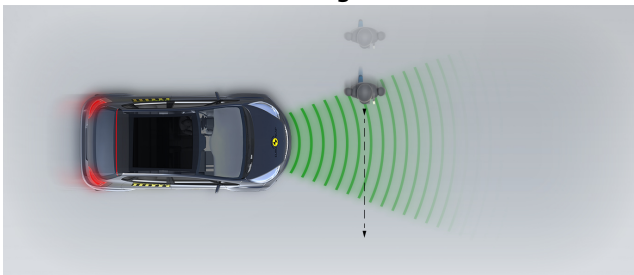
Adult crossing the road

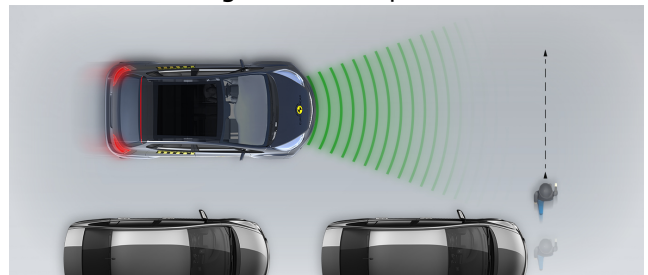
Child running from behind parked vehicles

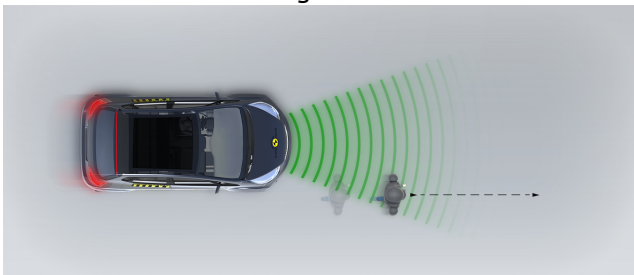
Adult along the roadside

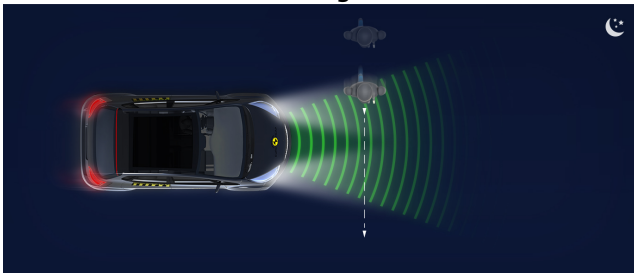
Adult crossing the road

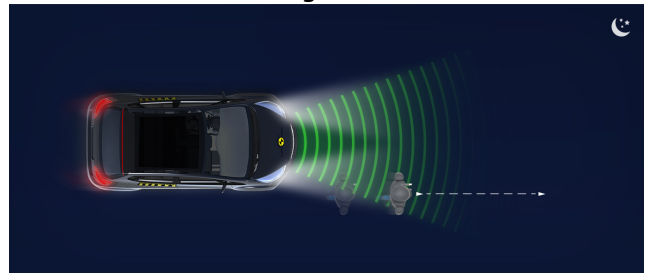
Adult along the roadside

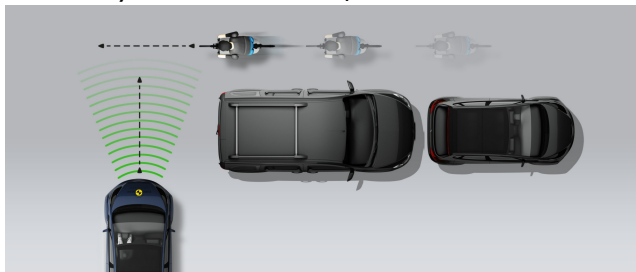
Cyclist from nearside, obstructed view

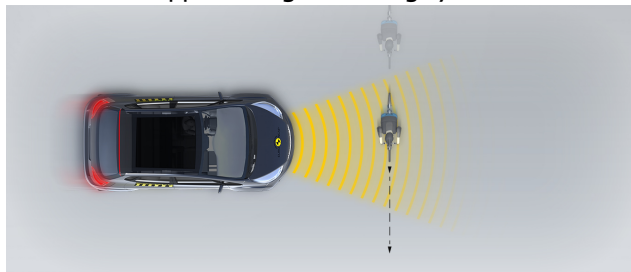
Approaching a crossing cyclist

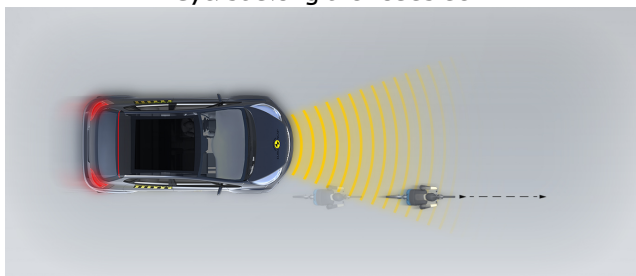
Cyclist along the roadside
