Polestar

Polestar 2
Standard Safety Equipment

2021

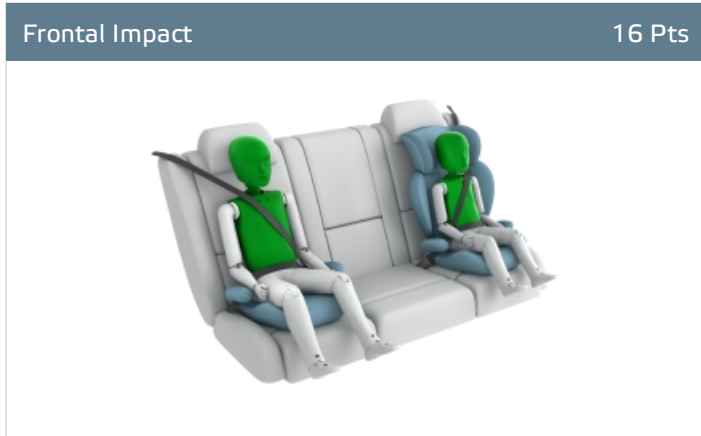
Crash Test Performance based on 6 & 10 year old children

Restraint for 6 year old child: *Volvo - Britax Römer Kidfix SL*
 Restraint for 10 year old child: *Osann junior booster cushion*

In both the frontal offset test and the side barrier impact, protection of both child dummies was good for all critical body areas and the Polestar 2 scored maximum points in this part of the assessment. The front passenger airbag can be disabled to allow a rearward-facing child restraint to be used in that seating position. Clear information is provided to the driver regarding the status of the airbag and the system was rewarded. All of the restraints for which the Polestar 2 is designed could be properly installed and accommodated.
