TEST RESULTS

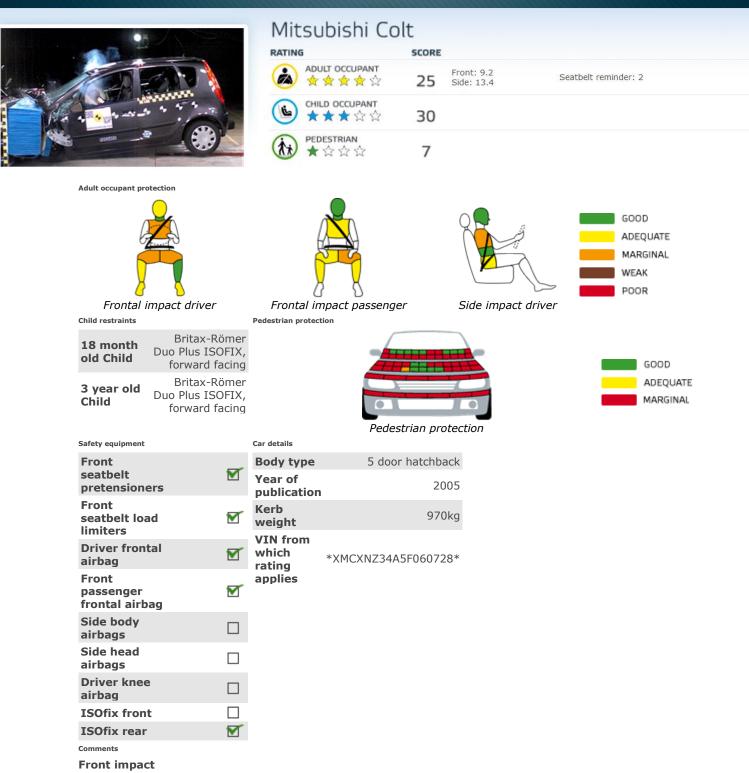
The driver dummy's head bottomed out the airbag and the chest made contact with the rim of the steering-wheel. Structures in the dashboard represented a potential hazard to the driver and passenger's knee and femur protection. Part of the power steering mechanism moved rearward, opening a spot-welded seam and rupturing the driver's footwell. Mitsubishi inform us that 5-door cars from chassis number *XMCXNZ34A5F075819* incorporate improvements to the footwell area, although Euro NCAP has not assessed the modified cars.

In the frontal impact, the 3 year old dummy's head moved forward further than Euro NCAP recommends. The passenger's airbag can be deactivated to allow a rearward-facing child restraint to be placed in that seating position. However, the switch for doing this did not meet Euro NCAP's requirements. The presence of the ISOFIX anchorages in the rear outboard seats was not sufficiently clearly marked.

Both the bumper and the leading edge of the bonnet scored no points for the protection they offered to pedestrians.
