## Smart forfour

RATING	SCORE	Front: 12	Side: 13	Seatbelt reminder: 1
  <b>ADULT OCCUPANT</b> ★★☆☆☆	<b>26</b>			
  <b>CHILD OCCUPANT</b> ★☆☆☆☆	<b>18</b>			
  <b>PEDESTRIAN</b> ★☆☆☆☆	<b>7</b>

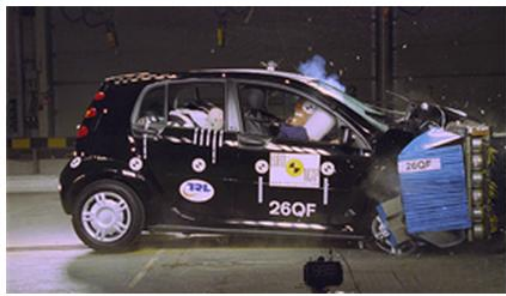
<b>Hand of drive</b>	RHD
<b>Tested model</b>	Smart forfour 1.3 Pulse
<b>Body type</b>	SUPERMINI
<b>Year of publication</b>	2005
<b>Kerb weight</b>	965
<b>VIN from which rating applies</b>	WME4540312B106784
