Volvo EX90  
Standard Safety Equipment

2025

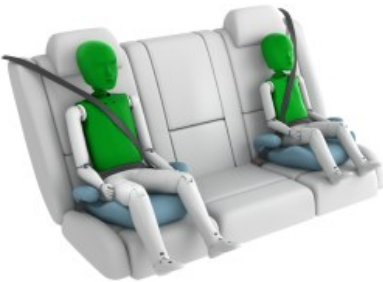
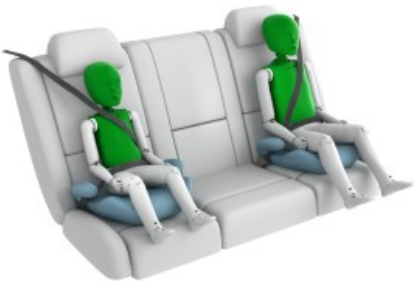
Crash Test Performance based on 6 & 10 year old children

| Frontal Impact | 16 Pts | Lateral Impact | 8 Pts |

Restraint for 6 year old child: *Volvo booster seat*  
Restraint for 10 year old child: *Volvo booster cushion*

In both the frontal offset and the side barrier tests protection of all critical body areas was good for the 6 and 10 year dummies, and the Volvo EX90 scored maximum points in this part of the assessment. The front passenger airbag can be disabled to allow a rearward-facing child restraint to be used in that seating position. Clear information is provided to the driver regarding the status of the airbag and the system was rewarded. The Volvo EX90 is equipped with a direct 'child presence detection' system which issues a warning when it detects that a child or infant has been left in the car. All of the child restraint types for which the Volvo EX90 is designed could be properly installed and accommodated in the car.
