Mercedes Benz C Class

Adult occupant protection

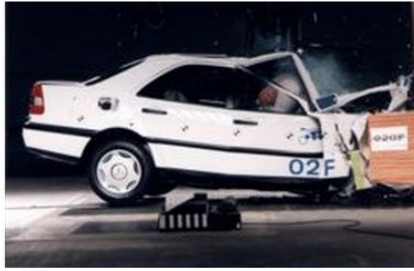
The Mercedes achieved a two-star front- and side-impact rating. In the frontal test, the C-class suffered excessive intrusion into the footwell area, where stiff structures that came into contact with the driver's right knee presented serious injury risks to his knee, thigh and pelvis. The C-class is due to be revised this autumn. For now, the car tested was fitted with driver and passenger airbags, which are standard equipment throughout Europe. It also had door-mounted airbags for additional side-impact protection. However in the side-impact test, with the seat set correctly for an adult male of average height, the door struck the dummy's chest before the side airbag had fully inflated. If the seat were set further back for a taller driver it was not clear from the test results how much more or less effective the airbag might have been.

The driver's front screen pillar was pushed backwards by 154mm (6.1in). The passenger compartment remained free from damage serious enough to affect its structural integrity and the driver's and passenger's doors could be opened normally after the impact. The steering wheel was pushed back by 123mm (4.8in) and upward by only 49mm (1.9in). However, there was excessive intrusion into the footwell – the brake pedal was moved backwards by 270mm (10.6in). The driver's head was cushioned by the airbag, giving a good dummy result. However, movement of the steering column was felt to present a potential risk to shorter and taller drivers, so head protection was down-rated to 'adequate'. Neck protection was good and the restraint system kept his chest away from the wheel. Although the driver's left knee struck the lower fascia just to the left of the steering column, protection for his left

knee, thigh and pelvis was rated as good. His right knee hit the fascia just to the right of the steering-column lock, but was given a 'poor' rating because, had the knee struck slightly higher, it would hit the column lock, and if it had penetrated the fascia slightly further, injury risks would have increased significantly. Excessive intrusion into the footwell resulted from the impact, and foot and ankle protection was rated 'poor' as a result. The level of protection provided for the front passenger was generally good and the airbag was effective, although forces exerted by the seat belt during the impact resulted in marginal protection for the chest, and his right lower leg struck the centre console hard enough to leave a clear damage mark. The results for the passenger were not modified on the basis of any structural damage caused by the impact.

The door-mounted airbag (fitted as standard to this car) was triggered by the impact, emerged from the door ahead of the driver and pushed rearwards between the driver and the door as it inflated. But, before this could happen, the dummy's upper chest was struck by the car side as it was pushed in by the impact. This test was carried out with the driver's seat set for a person of average height. Had the driver been much taller or shorter, the degree of protection provided by the side airbag might have been significantly different. Good protection was provided for the driver's head and pelvis, but the amount of protection provided for his chest was rated 'weak' because of the contact that had occurred between his ribs and the side of the car. Protection for his abdomen was rated as 'marginal'.
