Rover 100

RATING	SCORE

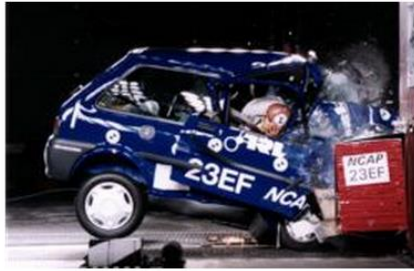
The Rover suffered excessive deformation of the passenger compartment in the frontal impact – the A-pillar on the driver's side was pushed back by 488mm – and the structure became unstable. This was because the driver's door split apart, allowing excessive collapse of the door aperture and intrusion of the fascia, which had partially come away from the car's side. Following frontal impact, the driver's door could only be opened by using tools. However, the passenger's door could be opened normally. The steering wheel was pushed back by an excessive 312mm. There was excessive intrusion of the footwell. The Rover suffered excessive deformation of the passenger compartment in the frontal impact – the A-pillar on the driver's side was pushed back by 488mm – and the structure became unstable. This was because the driver's door
