TEST RESULTS

VW Polo

Hand of drive	RHD
Tested model	Volkswagen Polo 1.4L
Body type	3 door hatchback
Year of publication	1997
Kerb weight	890

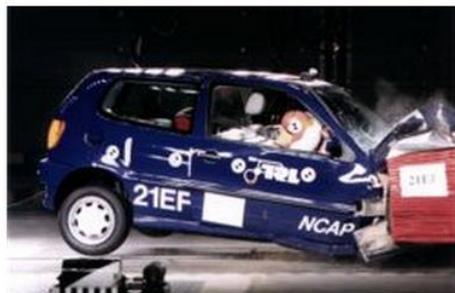
RATING	SCORE
ADULT OCCUPANT ★★☆☆	N/A
PEDESTRIAN ★☆☆☆	N/A <small>Pre 2002 rating</small>

The Volkswagen Polo was awarded three stars for protection in frontal and side impact. All the new frontal-impact criteria were met with the exception of the upward movement of the steering wheel in frontal impact, and the chest loading inside impact. In the frontal-impact crash test, there was limited intrusion of the passenger compartment which retained its stability. There were no particular problems with the knee-impact areas. Reducing the degree of intrusion in the footwell should improve protection of the feet and ankles. In side impact, reduced loading of the chest is needed, while, at the same time, controlling the loading on the pelvis.
