Audi A3

Adult occupant protection

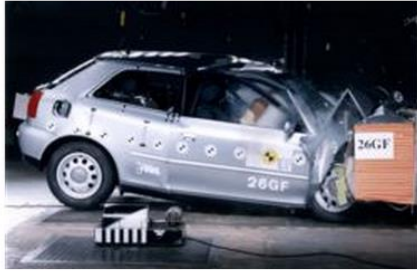
| ■ | GOOD |
| ■ | ADEQUATE |
| ■ | MARGINAL |
| ■ | WEAK |
| ■ | POOR |

The driver's door gave support to its aperture, which helped keep the body shell structurally sound. After the impact, the cabin remained stable and intrusion levels were relatively low. Both airbags provided stable support for the front occupants' heads. Seat belt loading on the chest could usefully be reduced, particularly for the passenger. The column lock, adjuster lever and bracket presented hazards in the knee impact area for the driver. These could cause high loads on his upper legs and damage to his knees.

The door is fitted with an aluminium beam that interlocks with the sill, extending its effective height while the door's profile against the occupant remains approximately vertical. The seat-mounted side airbags providing padding for the driver's chest and abdomen. After the impact, a gap of about 70mm remained between the door and the airbag module. The pelvis was loaded by the door bin behind which foam padding was fitted in the door.
