# Fiat Brava

<b>Hand of drive</b>	RHD
<b>Tested model</b>	Fiat Brava 1.4 S
<b>Body type</b>	5 door hatchback
<b>Year of publication</b>	1998
<b>Kerb weight</b>	1077
<b>VIN from which rating applies</b>	4726000

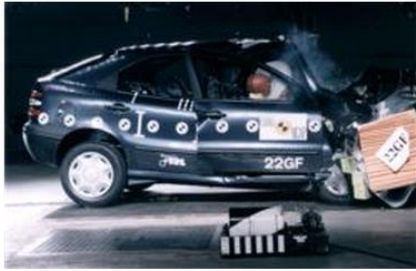
<b>ADULT OCCUPANT</b> ★★☆☆☆☆	<b>16</b> Front: 7 Side: 8

<b>PEDESTRIAN</b> ★☆☆☆☆	<b>11</b> Pre 2002 rating

The Brava was awarded two stars for frontal- and side-impact protection but, with only a small improvement, it would have been awarded a third star. The car's structure became overloaded in the frontal impact and there were significant intrusion problems. However, even without a side airbag, the car meets side-impact legislation to take effect across Europe for new models from October. Finally, the bonnet's leading edge provided better than average pedestrian protection.
