Honda Civic

Tested model	Honda Civic 1.4i
Body type	5 door hatchback
Year of publication	1998
Kerb weight	1115

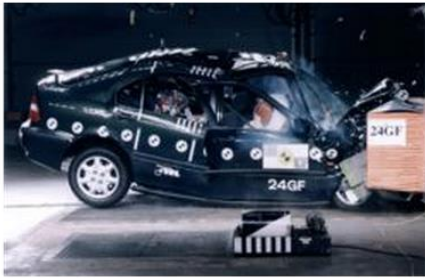
Adult occupant protection

The passenger compartment remained stable in the impact. Both airbags provided stable support for the heads of front seat occupants. However, there was limited intrusion of the steering wheel. Seat belt loading on the occupants' chest resulted in adequate protection for the driver but marginal protection for the passenger. Stiff structures adjacent to the steering column increased risk of injury to the driver's upper legs and there was also a risk of localised damage to his knees. Protection for his feet and ankles was poor because of excessive footwell intrusion.

The driver's head glanced the centre door pillar but acceleration remained low. His ribs were heavily loaded from contact with the door and the centre pillar and the car did not meet legislation applicable to new models introduced into Europe from next October. The abdomen and pelvis were struck by the door and the seat's side padding. This resulted in marginal abdomen protection but good pelvis protection.
