# Honda Logo

RATING	SCORE
<b>ADULT OCCUPANT</b> ★★☆☆☆	<b>17</b> Front: 6 Side: 11
<b>PEDESTRIAN</b> ★☆☆☆☆	<b>14</b> Pre 2002 rating

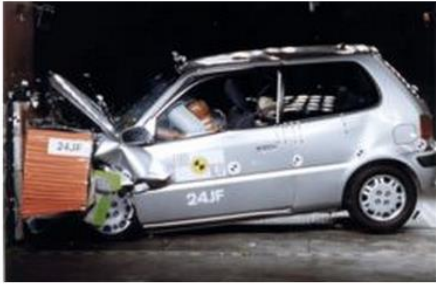
**Adult occupant protection**

Frontal impact driver

Frontal impact passenger

Side impact driver

- GOOD
- ADEQUATE
- MARGINAL
- WEAK
- POOR

The steering wheel moved only within allowable limits and head and neck protection was good. The restraint system put reasonably high loads on the chests of the driver and passenger. However, it was the lower body areas which were most at risk. The driver's right upper leg was subjected to great force, producing a high risk of pelvic injury. Protection for his knees was poor and the pedals were forced back, endangering his feet.

Unusually, the driver's head struck the door waist rail, which may have been the result of a high force transmitted by a pelvis pusher in the door trim. This block of expanded polystyrene foam also loaded the abdomen from below the armrest, which was also fractured in the impact.
