Lancia Ypsilon

RATING	SCORE

ADULT OCCUPANT ★★☆☆☆	14 Front: 3 Side: 10

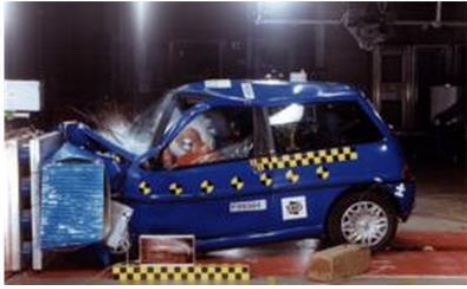
The Ypsilon's body became unstable, putting the driver at risk of serious injury. The trans-facia beam disconnected at the screen pillar and there was serious disruption in the footwell. The head contact on the airbag was unstable. In the side impact the door was forced in over the sill, damaging the seat and risking serious injury to the driver's pelvis. The central rear seat belt was of a simple two-point lap type that could cause severe abdominal and spinal injuries. The child restraints had poor instruction labels and did not give good sideways support.
