# Hyundai Elantra

RATING	SCORE	Details

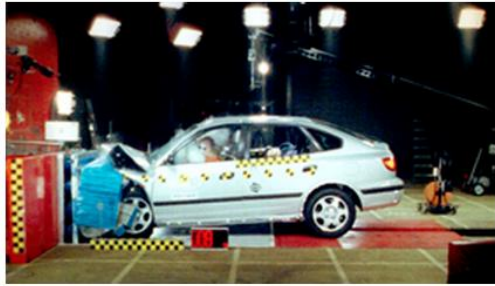
## Adult occupant protection

Frontal impact driver

Frontal impact passenger

Side impact driver

The airbag deployed but the driver's head and chest hit the steering wheel. These results indicated a risk of injury and the driver might suffer worse harm if the circumstances were different. Testers also found hard areas beneath the fascia that could injure the driver's legs and knees. The clutch pedal was driven a long distance rearwards by the impact, presenting a risk to his lower limbs. What's more, the force of the impact moved his seat upwards and outwards, slackening his belt and increasing his chances of suffering serious injuries as a result. On a more positive note, the Elantra's centre rear passenger is given a three-point belt which provides greater protection than a static, lap-only belt could.

The rear door on the side of the car struck in the impact opened and anyone in the rear risked ejection. Otherwise, the Elantra performed well, although the driver ran a limited risk of sustaining abdominal injuries.
