GEELY EX5

Standard Safety Equipment

2025

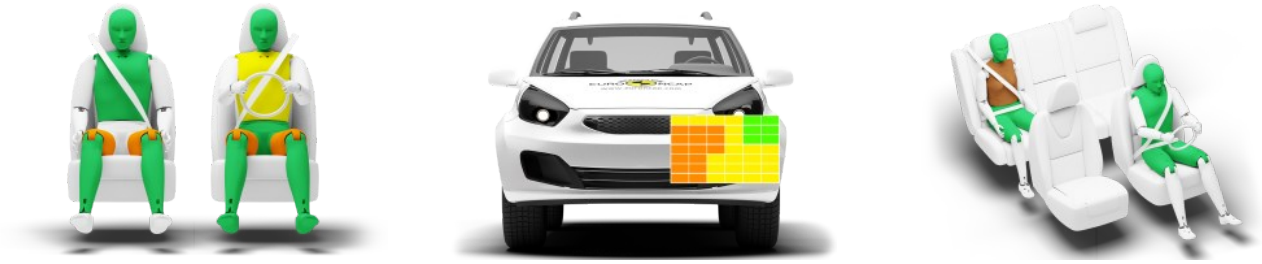
Frontal Impact — 12.3 / 16 Pts

In the frontal offset test of the GEELY EX5, several welds around the base of the A-pillar became detached, and there was some tearing of the metal. GEELY showed that the structure did not incur significantly greater damage in a more severe test, but a penalty was applied to the score. Dummy readings indicated good protection of the knees and femurs of both front seat occupants. Owing to the bodyshell damage, GEELY were precluded from demonstrating a similar level of protection would be provided to occupants of different sizes and to those sitting in different positions. Analysis of the deceleration of the impact trolley during the test, and analysis of the deformable barrier after the test, revealed that the GEELY EX5 would be a moderately benign impact partner in a frontal collision. In the full-width rigid barrier test, protection of the rear passenger's chest was rated as weak, based on dummy readings of compression. In both the side barrier test and the more severe side pole impact, good or adequate protection was provided to all critical parts of the body. Control of excursion (the extent to which a body is thrown to the other side of the vehicle when it is hit from the far side) was found to be good. The GEELY EX5 has a countermeasure to mitigate against occupant-to-occupant injuries in such impacts. The airbag performed well in Euro NCAP's tests with dummy readings indicating good protection for both the driver and passenger. Tests on the front seats and head restraints demonstrated good protection against whiplash injuries in the event of a rear-end collision. A geometric analysis of the rear seats also indicated good whiplash protection. The car has an advanced eCall system which alerts the emergency services in the event of a crash, and a system to prevent secondary impacts after the car has been in a collision. GEELY demonstrated that the doors and windows would be openable to allow occupants to escape in the event of vehicle submergence.
