TEST RESULTS

Tested Model	Hyundai BAYON 1.0 T-GDI GL, LHD
Body Type	- 5 door SUV
Year Of Publication	2021
Kerb Weight	1230kg
VIN From Which Rating Applies	- from NLHBR81GVNZ144410
Class	Supermini

The Hyundai i20 is very closely related to the Hyundai BAYON tested by Euro NCAP in 2021 and shares the same safety equipment. Based on data reviewed by Euro NCAP, the two cars can be considered identical as far as safety is concerned and the rating of the BAYON can be applied also to the i20.

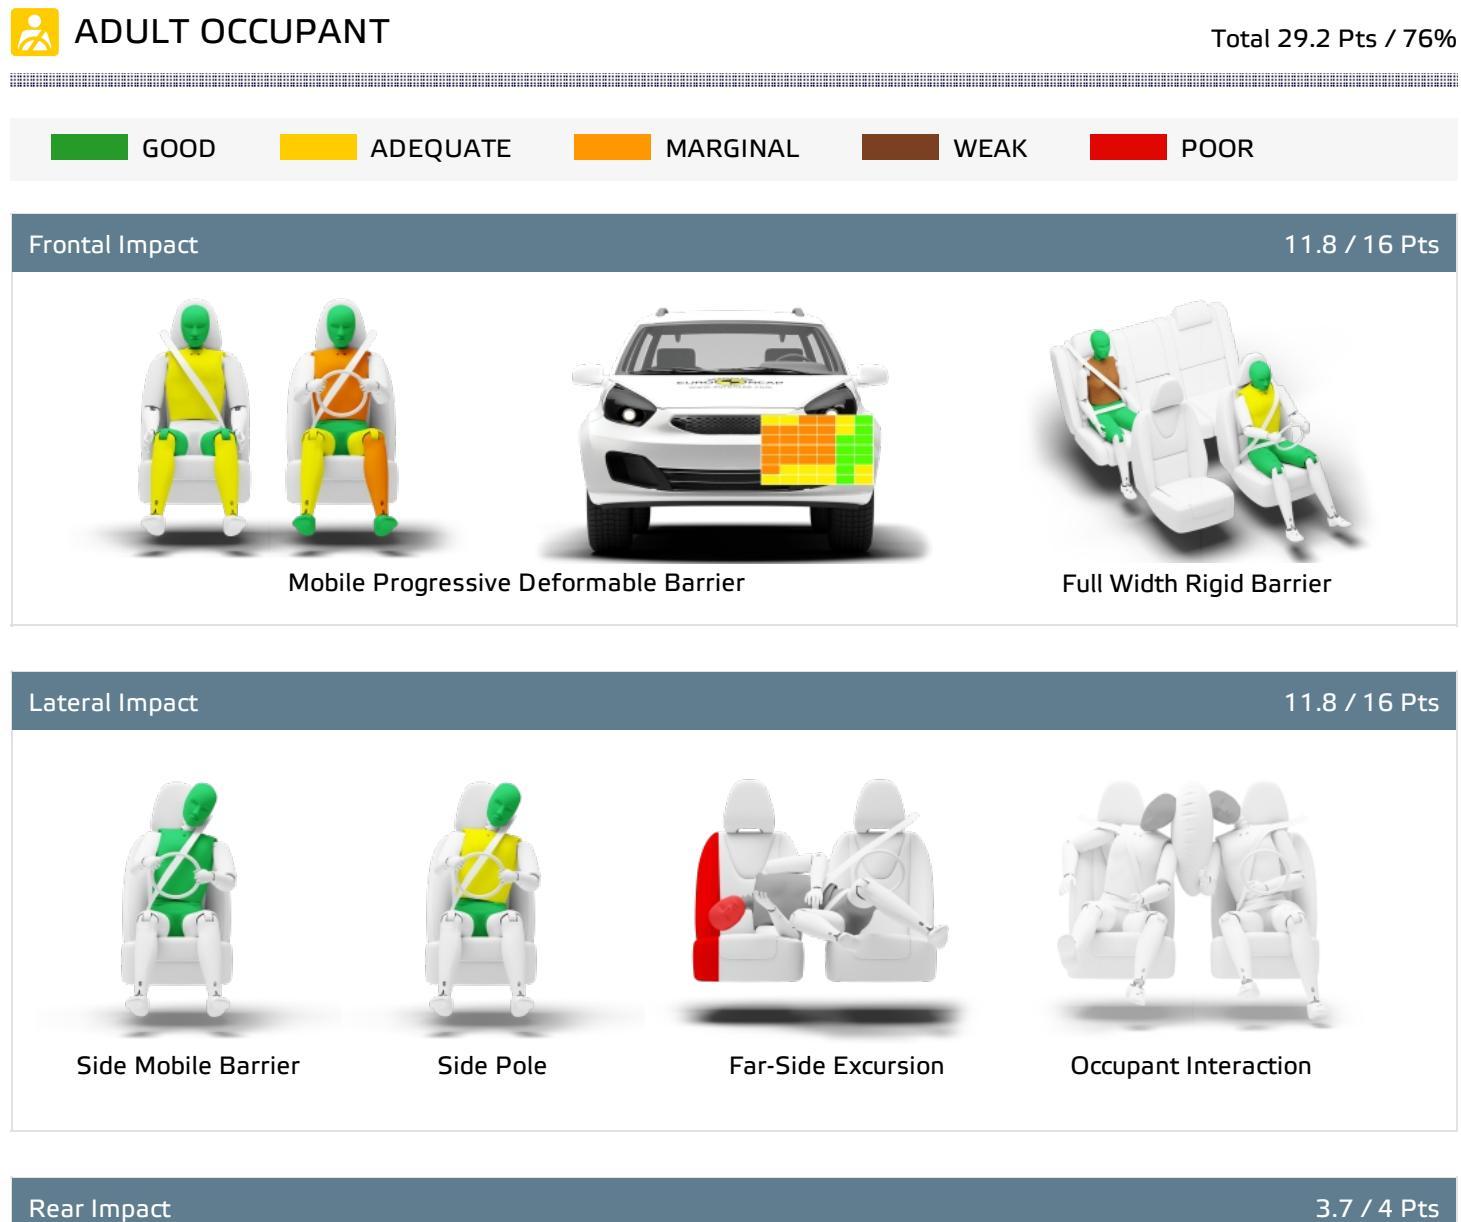
The passenger compartment remained stable in the frontal offset test. Dummy numbers showed good protection of the knees and femurs of both the driver and passenger. Hyundai showed that, on the passenger's side, a similar level of protection would be provided to occupants of different sizes and to those sitting in different positions. However, on the driver's side, structures in the dashboard were considered a risk to occupants' legs and a penalty was applied to the score. Protection of the driver's chest was rated as marginal, based on dummy readings of chest compression. Analysis of the deceleration of the impact trolley during the test, and analysis of the deformable barrier after the test, revealed that the car would be a benign impact partner in a frontal collision. In the full-width rigid barrier test, protection of all critical body areas was good and the car scored maximum points in this part of the assessment. In the more severe side pole impact, protection of all critical body areas was good or adequate. The car is not equipped with a counter-measure to mitigate occupant to occupant injuries in the event of a side impact. Mitigation of the extent to which a body would be thrown to the opposite side of a car in a lateral collision was rated as poor. Tests on the front seats and head restraints demonstrated good protection. The car is equipped with an advanced eCall system which alerts the emergency services in the event of a crash, and with MCB, a system which applies the brakes after a collision to reduce the likelihood of secondary impacts.

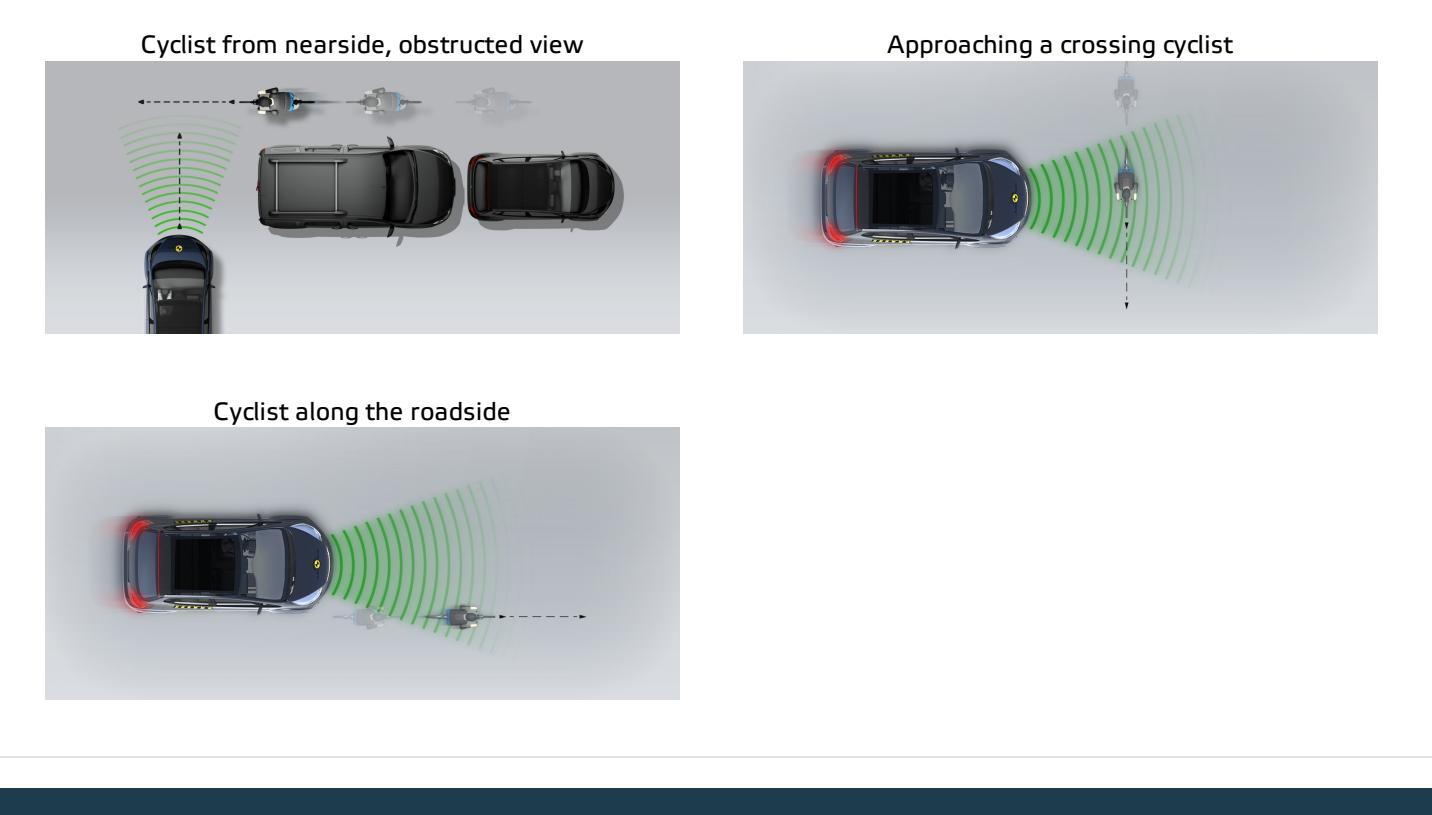
AEB Cyclist

The protection provided by the bonnet to the head of a struck pedestrian was mixed but was mostly rated as between marginal and good. Poor results were recorded at the base of the windscreen and on the stiff windscreen pillars. The bumper provided good protection to pedestrians' legs at all test locations and protection of the pelvis was also good, the car scoring maximum points in these areas of assessment. The autonomous emergency braking system detects vulnerable road users, as well as other vehicles. The system's response to pedestrians was adequate and its response to cyclists was good, with collisions avoided or mitigated in most test scenarios.
