TEST RESULTS

Opel/Vauxhall Vectra

Pre 2002 rating

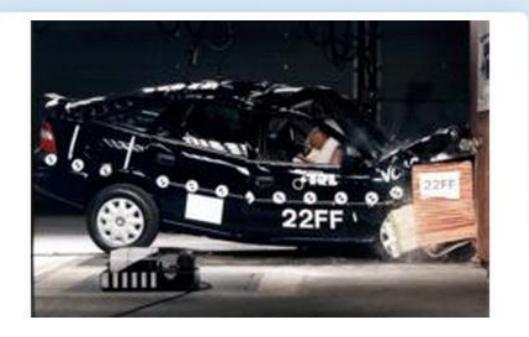
The Vectra sustained footwell intrusion in the frontal impact, the driver ran a high risk of suffering life-threatening chest injuries in the side-impact test; the car would fail to meet forthcoming side-impact legislation for new models. The amount by which the steering intruded into the cabin in the frontal impact also gave cause for concern. However, in the side-impact test, protection for the driver's head and pelvis was good.
