Suzuki Baleno
Standard Safety Equipment

2016

SPECIFICATION

Tested Model	Suzuki Baleno
Body Type	5 door hatchback
Year Of Publication	2016
Kerb Weight	890kg
VIN From Which Rating Applies	- all Balenos
Class	Supermini

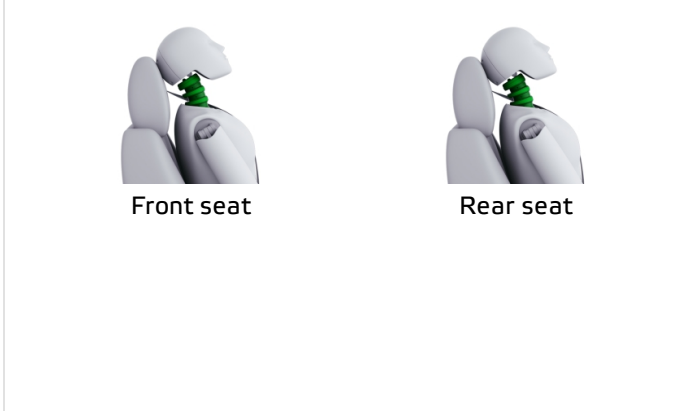
Whiplash Rear Impact 2.6 Pts

Detailed description: This panel shows two crash test dummies seated in a car, viewed from the rear. The dummy on the front seat is marked with a green 'Good' rating, and the dummy on the rear seat is marked with a green 'Good' rating.
