Toyota Hilux
Standard Safety Equipment

2016

Tested Model	Toyota Hilux Double-Cab, 2.4 diesel 4x4, mid grade, LHD
Body Type	- Pickup
Year Of Publication	2016
Kerb Weight	2050kg
VIN From Which Rating Applies	- All Hilux double-cabs
Class	Pick-up

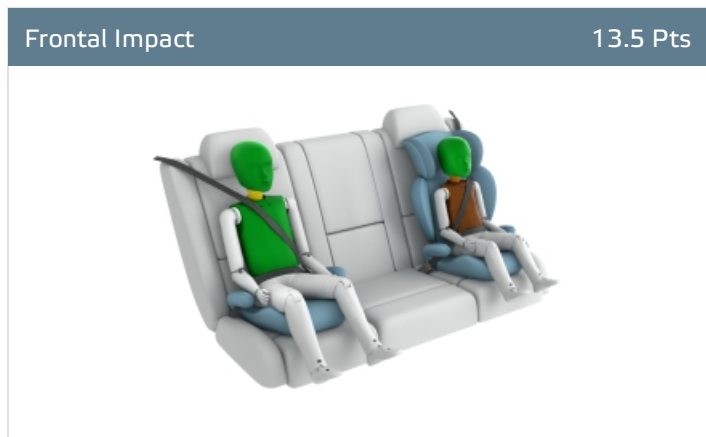
Crash Test Performance based on 6 & 10 year old children

Restraint for 6 year old child: *Toyota KidFix XP SICT*

Restraint for 10 year old child: *Graco Junior*

In the frontal offset test, neck tension and chest deceleration revealed, respectively, marginal and weak protection for those body areas in the 6 year dummy. Protection of the 10 year dummy was good, apart from adequate protection of the neck, and, in the side impact was good for all critical body areas for both child dummies. The Hilux has an automatic system for disabling the front passenger airbag when, for example, a rearward-facing child restraint is used in that position. The system met Euro NCAP's requirements and was rewarded. All child restraints for which the Hilux is designed could be accommodated. However, the group 1 ISOFIX seat needed care to ensure correct installation and the rear centre seat is deemed unsuitable for child restraints by Toyota, although restraints could be properly installed there.
