**Suzuki Ignis**  
Standard Safety Equipment

2016

Tested Model	Suzuki Ignis 1.2 GL, 4x2, LHD
Body Type	- 5 door hatchback
Year Of Publication	2016
Kerb Weight	820kg
VIN From Which Rating Applies	- all Ignis variants
Class	Supermini

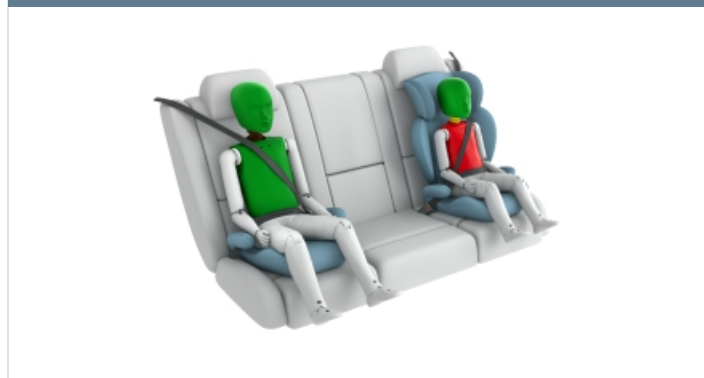
Frontal Impact 11.8 Pts

In the frontal offset test, chest decelerations of the 6 year dummy's chest showed poor protection, exceeding recommended safe limits. Similarly, neck tensile forces in the 10 year dummy indicated weak protection of this part of the body. The front passenger airbag can be deactivated to allow a rearward-facing child restraint to be used in this sitting position. Clear information is provided to the driver regarding the status of the airbag and the system was rewarded. All of the restraint types for which the Ignis is designed could be properly installed and accommodated in the car.
