**SsangYong Tivoli**  
With Safety Pack

2016

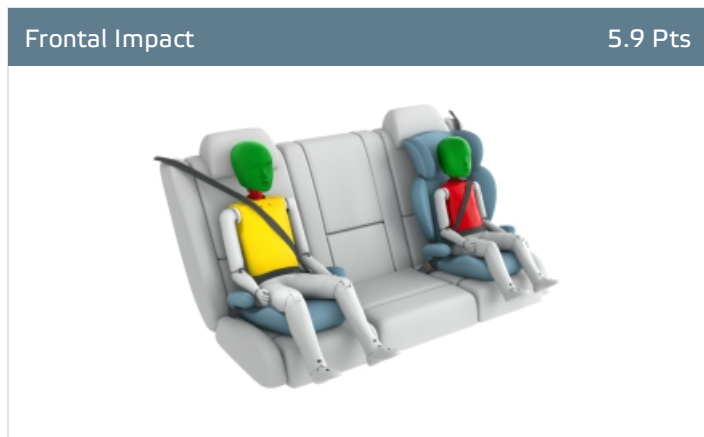
Crash Test Performance based on 6 & 10 year old children

Restraint for 6 year old child: *Romer KidFix XP*  
 Restraint for 10 year old child: *Graco Junior*

In the frontal offset test, protection of the 10 year dummy's neck was rated as poor, based on dummy readings of neck tensile forces. Similarly, decelerations in the chest of the 6 year dummy indicated poor protection of this body region. In the side impact, both dummies were properly restrained and protected. The front passenger airbag can be disabled to allow a rearward facing child restraint to be used in that seating position. However, the information provided to the driver regarding the status of the airbag did not meet Euro NCAP's requirements and the system was not rewarded. All of the restraint types for which the Tivoli is designed could be properly installed and accommodated. The user manual states that the front passenger seat is not suitable for iSize restraints and the Tivoli lost points for those restraints in that seating position.
