**MG ZS**  
Standard Safety Equipment

2017 ★★☆☆☆

## SPECIFICATION

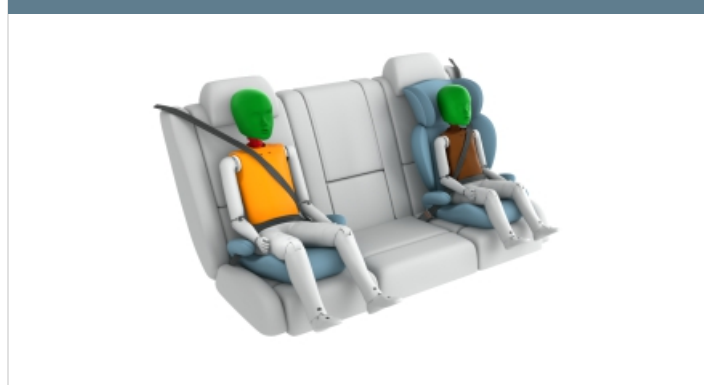
Frontal Impact 5.6 Pts

In the frontal offset test, protection of the neck of the 10 year dummy was rated as poor, based on measured values of tensile forces. Protection of the chest was marginal. For the 6 year dummy, protection of the chest and neck was weak, based on decelerations and tensile forces. In the side barrier test, the head of the 10 year dummy 'bottomed out' the airbag and injury criteria indicated poor protection for this part of the body. The front passenger airbag can be disabled to allow a rearward-facing dummy to be used in that seating position. Clear information is provided to the driver regarding the status of the airbag and the system was rewarded. There was insufficient seatbelt length to install Universal restraints properly in the front passenger seat. The same was true for one Universal seat in the rear centre seat and one other was unstable when installed. Otherwise, restraints could be properly installed and accommodated.
