Hyundai i20  
Supermini

2015

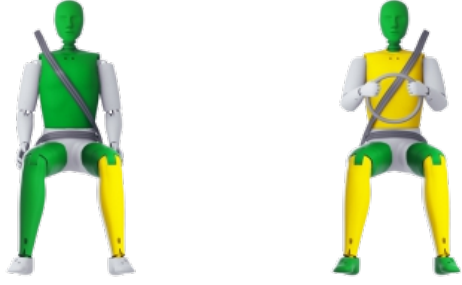
**Frontal Offset Deformable Barrier** 7.7 Pts

Passenger                      Driver

The passenger compartment remained stable in the frontal offset test. Dummy readings indicated good protection of the knees and femurs of the driver and front passenger. Hyundai showed that a similar level of protection would be provided to occupants of different statures and to those sat in different positions. In the full-width rigid barrier test the restraint systems provided adequate protection to the driver's chest and to the rear passenger's neck and chest, and good protection to other body regions. In both the side impact barrier test and the side pole test, dummy readings showed good protection for all critical body areas. However, during both tests, the rear edge of the curtain airbag was trapped by part of the interior trim so did not fully deploy as intended. This was penalised and the protection of the head was rated as adequate. Hyundai are investigating the cause of the unintended airbag deployment behaviour. Tests showed that good protection against whiplash injuries would be provided to front seat occupants. A geometric assessment of the rear seats indicated a marginal level of protection against whiplash injuries. The i20 does not have an autonomous emergency braking system.
