**Volvo V90**  
Standard Safety Equipment

2017

## SPECIFICATION

Tested Model	Volvo S90 D4 'Momentum', LHD
Body Type	- 4 door Saloon
Year Of Publication	2017
Kerb Weight	1828kg
VIN From Which Rating Applies	- all V90s
Class	Executive

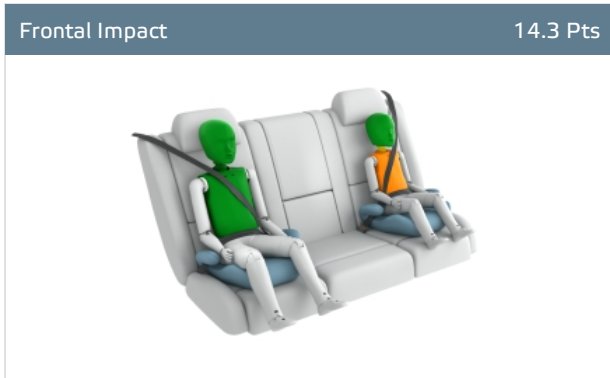
Crash Test Performance based on 6 & 10 year old children

Restraint for 6 year old child: *Volvo Integrated Booster Cushion*  
 Restraint for 10 year old child: *Volvo Integrated Booster Cushion*

In the frontal offset test, protection of the 10 year dummy was good for all parts of the body, and maximum points were scored. Chest decelerations in the 6 year dummy indicated marginal performance but protection was otherwise good or adequate. In the side barrier test, protection of both 6 and 10 year dummies was good for all critical body areas and maximum points were scored. The front passenger airbag can be disabled to allow a rearward-facing child restraint to be used in that seating position. Clear information is provided to the driver regarding the status of the airbag and the system was rewarded. All of the child restraint types for which the vehicle is designed could be properly installed and accommodated.
