**Citroën C3**  
Standard Safety Equipment

2017 ★★★★★

Tested Model	Citroën C3 1,2 PureTech 82 FEEL, LHD
Body Type	- 5 door hatchback
Year Of Publication	2017
Kerb Weight	1072kg
VIN From Which Rating Applies	- all C3s
Class	Supermini

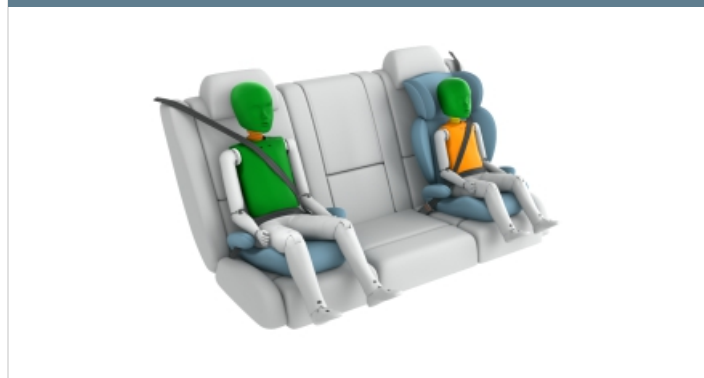
Frontal Impact 14 Pts

In the frontal offset test, readings of neck tension in the 10 year dummy, and of chest deceleration in the 6 year dummy indicated a marginal level of protection. Otherwise, protection was adequate or good. In the side barrier test, protection was good for all critical parts of the body. The front passenger airbag can be disabled to allow a rearward-facing child restraint to be used in that seating position. Clear information is provided to the driver and the system was rewarded. All of the restraint types for which the C3 is designed could be properly installed and accommodated in the car.

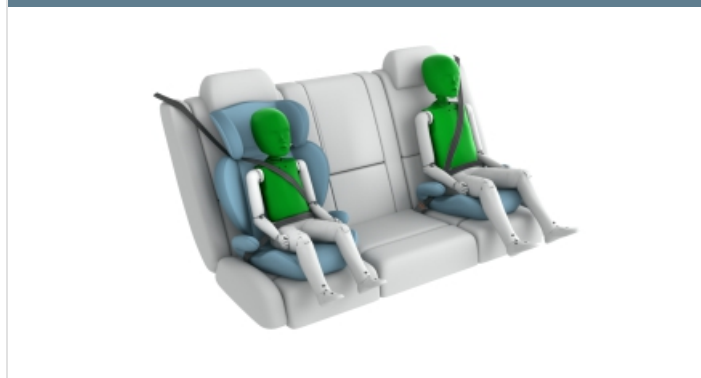
Lateral Impact 8 Pts
