Mitsubishi L200  
Pick-up

2015

Tested Model	Mitsubishi L200 'GLS'
Body Type	- 4 door double cab
Year Of Publication	2015
Kerb Weight	1860kg
VIN From Which Rating Applies	- applies to all L200s of the specification tested
Class	Pick-up

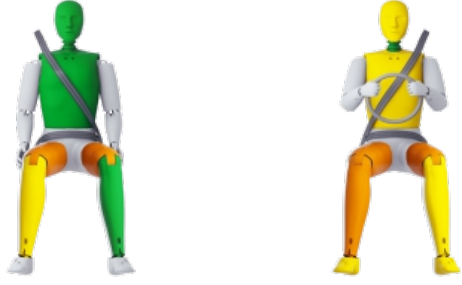
**Frontal Offset Deformable Barrier** 5.3 Pts

In the frontal offset test, there was extensive deformation of the bodyshell. There was a rupture of the floorpan in the driver's seating position, considerable buckling of the floor in the rear of the passenger compartment and spot welds had failed at the point where the bottom sill meets the C-pillar (the rearmost pillar of the passenger compartment). The car was penalised for this and Mitsubishi were precluded from demonstrating that structures in the instrument panel, such as the steering column and column shroud, would not present a risk of injury to the knees and femurs of occupants in the front seats. Protection of the knees, femurs and pelvis was rated as marginal. There was also insufficient pressure in the airbag to prevent the driver's head from bottoming-out against the steering wheel. Dummy head readings showed that contact had been made with the steering wheel through the deflated airbag and protection of the head was downgraded to adequate. In the full width rigid barrier test, protection of the driver dummy was good for all critical body areas while, for the rear passenger, protection of the neck was adequate and that of the chest was marginal. In both side impact tests - the side barrier and more severe side pole - the L200 scored maximum points, with good protection of all critical body areas. The front seats and head restraints showed good protection against whiplash injury in the event of a rear-end collision and a geometric assessment of the rear seats also indicated good whiplash protection. The L200 does not have an autonomous emergency braking system to assist further in whiplash protection.
