VW up!
Standard Safety Equipment

2019

Tested Model	VW e-up! 'Move Up', LHD
Body Type	- 5 door hatchback
Year Of Publication	2019
Kerb Weight	1164kg
VIN From Which Rating Applies	- all VW up!s
Class	Supermini

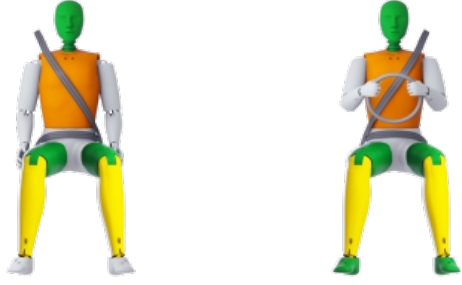
Frontal Offset Deformable Barrier 6.6 / 8 Pts

The passenger compartment of the up! remained stable in the frontal offset test. Dummy readings indicated good protection of the knees and femurs of the driver and passenger. VW showed that a similar level of protection would be provided to occupants of different sizes and to those sitting in different positions. Chest protection of both dummies was marginal. In the full-width rigid barrier test, protection of the chest was again marginal for both occupants, with other critical body areas well or adequately protected. In the side barrier impact, all critical body areas were well protected and the up! scored maximum points in this test. In the more severe side pole test, protection of the chest was adequate and that of other body areas was good. Tests on the front seats and head restraints demonstrated good protection against whiplash injuries in the event of a rear-end collision. A geometric assessment of the rear seats indicated marginal whiplash protection. An autonomous emergency braking (AEB) system is not available on the up!
