Mercedes-EQ EQC
Standard Safety Equipment

2019

SPECIFICATION

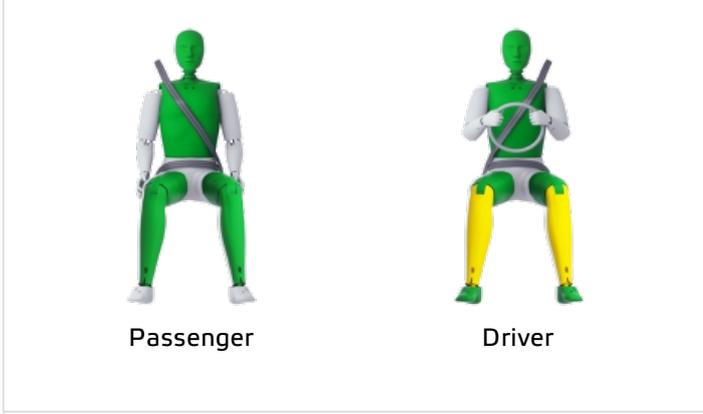
Frontal Offset Deformable Barrier 7.8 / 8 Pts

Passenger Driver

Detailed description: This panel shows two crash test dummies. The Passenger dummy is entirely green, indicating a 'GOOD' result. The Driver dummy has green legs and a yellow torso, indicating 'ADEQUATE' results for those areas.

The passenger compartment of the EQC remained stable in the offset frontal test. Dummy readings indicated good protection of the knees and femurs of both the driver and passenger. Mercedes-Benz showed that a similar level of protection would be provided to occupants of different sizes and to those sitting in different positions. For the passenger, protection of all critical body areas was good. Likewise, in the full-width rigid barrier test, protection of the driver was good for all critical body parts. For the rear passenger, dummy readings of chest compression indicated a marginal level of protection for this part of the body, with good or adequate protection elsewhere. In the side barrier impact, the EQC scored maximum points with good protection all-round. Dummy readings indicated good protection for all critical body areas in the more severe side pole test, too. However, a post-test inspection revealed that the upper hinge of the rear impacted-side door had broken, and the car was penalised. Tests on the front seats and head restraints demonstrated good protection against whiplash injuries in the event of a rear-end collision. A geometric assessment of the rear seats indicated marginal whiplash protection. The standard-fit autonomous emergency braking (AEB) system performed well in tests at the low speeds at which many whiplash injuries occur, with collisions against another vehicle avoided or mitigated in all test scenarios.

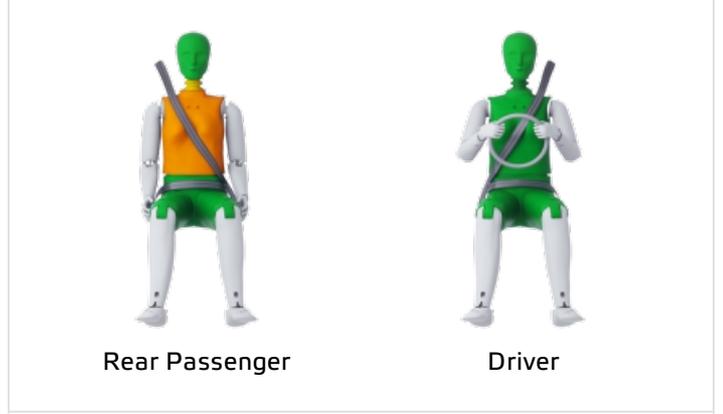
Frontal Full Width 7.6 / 8 Pts

Rear Passenger Driver

Detailed description: This panel shows two crash test dummies. The Rear Passenger dummy has a yellow torso and green legs, indicating 'ADEQUATE' results for the torso and 'GOOD' for the legs. The Driver dummy is entirely green, indicating a 'GOOD' result.

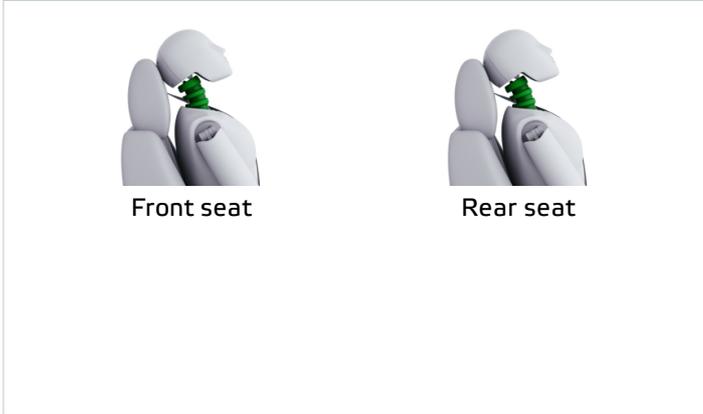
Whiplash Rear Impact 1.7 / 2 Pts

Front seat Rear seat

Detailed description: This panel shows two views of a seat headrest. The Front seat view shows a green neck area, indicating a 'GOOD' result. The Rear seat view shows a yellow neck area, indicating an 'ADEQUATE' result.

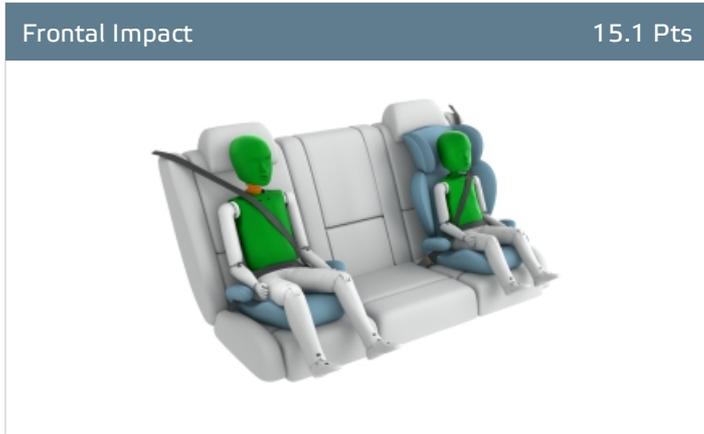
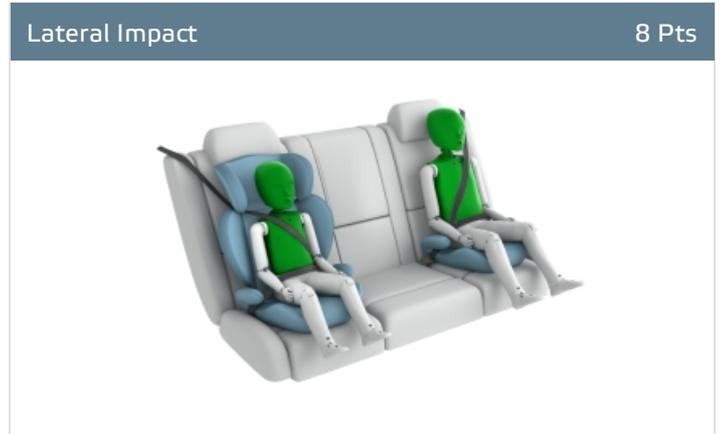
Crash Test Performance based on 6 & 10 year old children

23.1 / 24 Pts

Restraint for 6 year old child: *Mercedes-Benz Kidfix XP*
 Restraint for 10 year old child: *Booster Cushion*

In the frontal offset test, protection of all critical body regions was good for both child dummies, with the exception of the neck of the ten-year dummy where readings of neck tension indicated marginal protection. In the side barrier test, protection was good for all critical body areas for both dummies and the EQC scored maximum points in this part of the assessment. The front passenger airbag is automatically disabled when a rearward-facing child restraint is put in that seating position. Tests showed that the system worked robustly and the system was rewarded. All of the child restraint types for which the B-Class is designed could be properly installed and accommodated.
