Kia Rio
Standard Safety Equipment

2017

Tested Model	Kia Rio 1.2 GLS, LHD
Body Type	- 5 door hatchback
Year Of Publication	2017
Kerb Weight	1040kg
VIN From Which Rating Applies	- all Rios
Class	Small Family Car

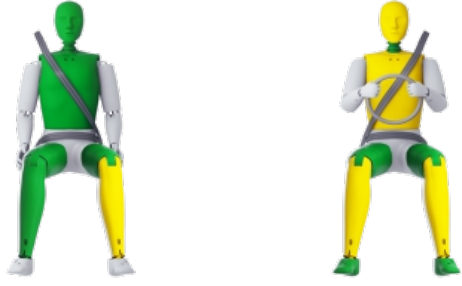
Frontal Offset Deformable Barrier 6.8 Pts

The passenger compartment remained stable in the frontal offset test. There was insufficient pressure in the driver's airbag to prevent the head from 'bottoming out' the airbag. Protection of the head was downgraded to adequate as a result. Dummy readings indicated good protection of the knees and femurs of both the driver and passenger. Kia showed that a similar level of protection would be provided to occupants of different sizes and to those sat in different positions. In the full-width rigid barrier test, protection of critical body areas was good or adequate for the driver and rear passenger. In the side barrier test and in the more severe side pole impact, protection of all critical parts of the body was good and the Rio scored maximum points in these tests. Tests on the front seats and head restraints demonstrated good protection against whiplash injuries in the event of a rear-end collision while a geometric assessment of the rear seats indicated marginal whiplash protection. The Rio has, as part of its optional safety pack, an autonomous emergency braking system but the results of those tests are not included in this rating.

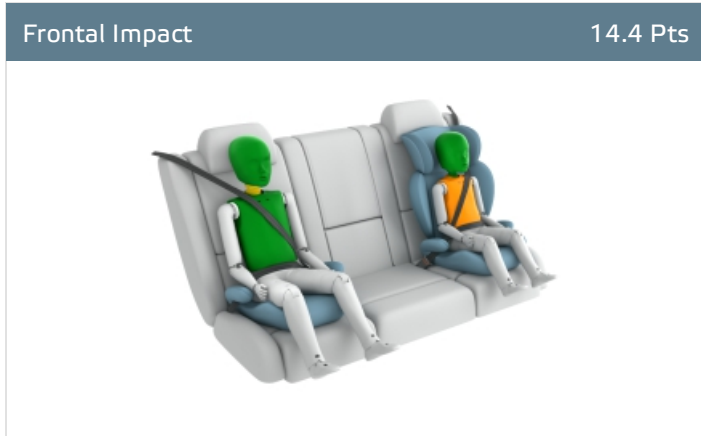
Crash Test Performance based on 6 & 10 year old children

Restraint for 6 year old child: *Britax Römer KidFix II XP*
 Restraint for 10 year old child: *Graco Junior III*

In the frontal offset test, protection of the chest of the 6 year dummy was rated as marginal, based on dummy readings of chest decelerations. Otherwise, protection of the 6 and 10 year dummies was good or adequate. In the side barrier test, protection of both dummies was good. The front passenger airbag can be disabled to allow a rearward-facing child restraint to be used in that seating position. Clear information is provided to the driver regarding the status of the airbag and the system was rewarded. All of the restraint types for which the Rio is designed could be properly installed and accommodated in the car with the exception of the Group II/III universal restraint which was unstable in the rear centre position.
