Kia Picanto
Standard Safety Equipment

2017

SPECIFICATION

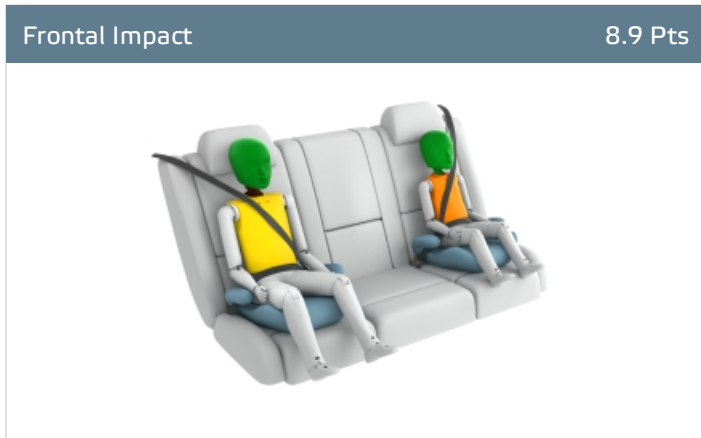
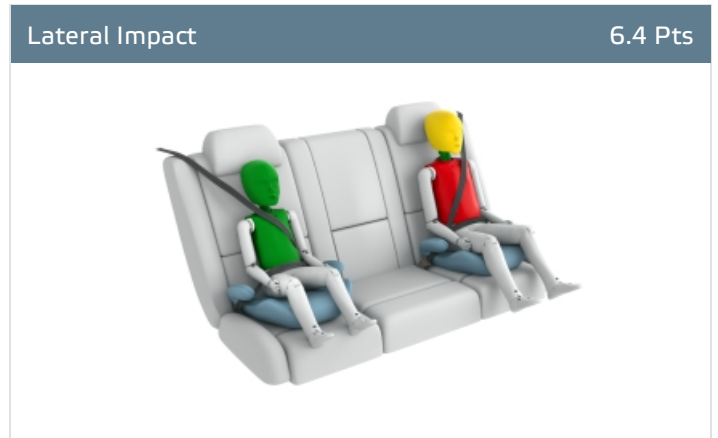
Crash Test Performance based on 6 & 10 year old children

In the frontal offset test, dummy readings of neck tension indicated weak protection of this part of the body for the 10 year dummy. Chest protection for the 6 year dummy was rated as marginal. In the side barrier test, protection of the 6 year dummy was good. However, protection of the chest was poor for the 10 year dummy, sat on the struck side of the car and the head made contact with the vehicle interior. The front passenger airbag can be disabled to allow a rearward-facing child restraint to be used in that seating position. Clear information is provided to the driver regarding the status of the airbag and the system was rewarded. The rear centre seat cannot accommodate universal child restraints which make use of the seatbelt. Otherwise, restraints could be properly installed and accommodated by the car.
