Renault Mégane Small Family Car

2015 < \star \star \star \star

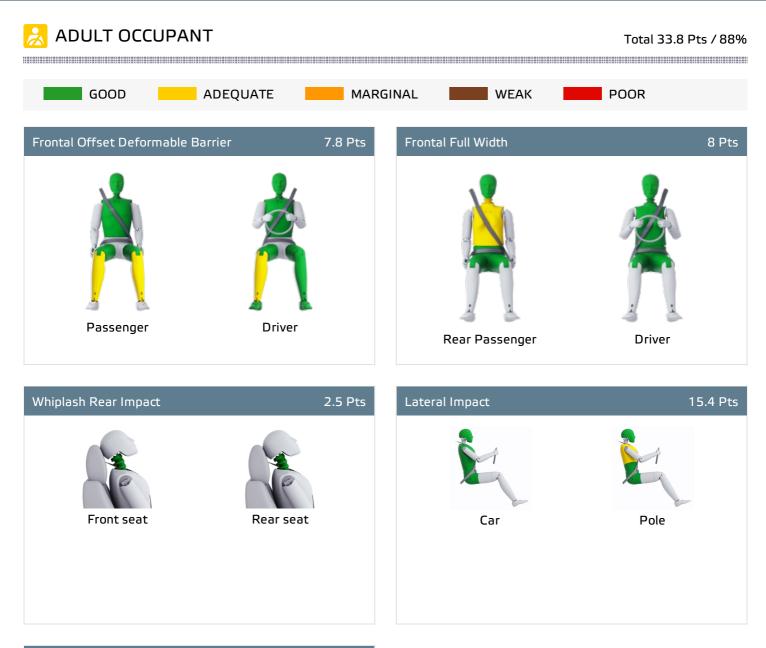
The passenger compartment of the Mégane remained stabled in the frontal impact. Dummy readings indicated good protection of the knees and femurs of the driver and passenger. Renault showed that a similar level of protection would be provided to occupants of different sizes and those sat in different positions. In the side barrier impact, protection was good for all body critical body regions, and the car scored maximum points. In the more severe side pole test, protection of the chest was rated as adequate, with good protection of other parts of the body. In Euro NCAP's tests, the front seats and head restraints demonstrated good protection against whiplash injury in the event of a rear-end collision. A geometric assessment of the rear seats indicated good protection also for occupants of those seats. A low-speed autonomous emergency braking system is not available on the Mégane.

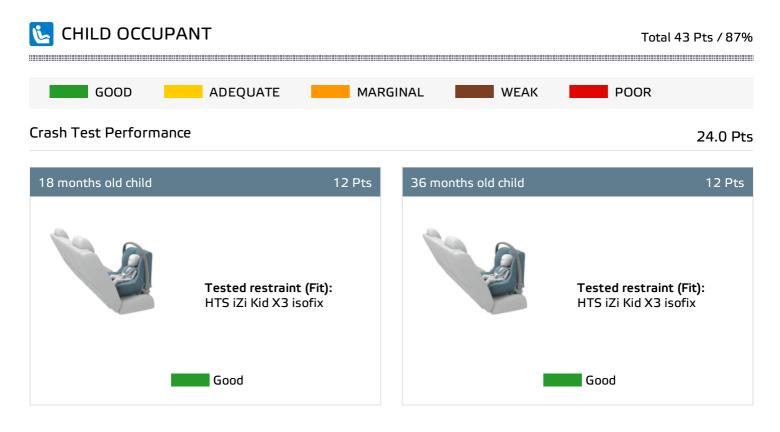
The Mégane scored full points for its protection of both the 11/2 year dummy and the 3 year dummy in the full scale crash tests. Both were seated in rearward-facing restraints. In the side barrier test, both dummies were properly contained within the protective shells of their restraints, minimising the risk of contact with parts of the vehicle interior. The front passenger airbag can be disabled to allow a rearwardfacing child restraint to be used in that seating position. Clear information is provided to the driver about the status of the airbag and the system was rewarded. All of the restraint types for which the Mégane is designed could be correctly installed and accommodated in the car.

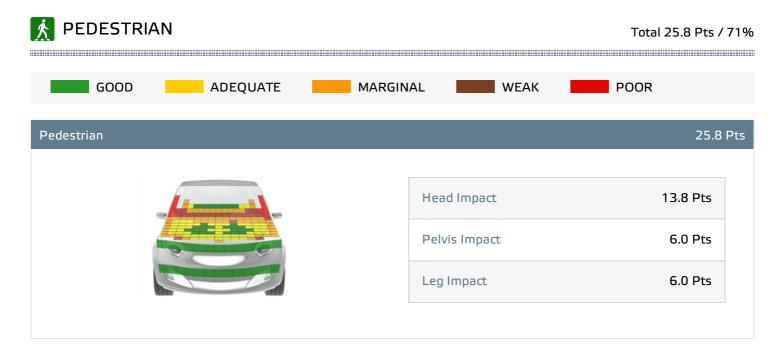
The bumper scored maximum points for its protection of pedestrians' legs, with good results at all test points. Likewise, the Mégane provided good protection to the pelvic region of a struck pedestrian. The protection provided by the bonnet to the head of a struck pedestrian was predominantly good or adequate, with poor results recorded only on the stiff windscreen pillars.
