**BMW X1 / X2**  
Small Off-Road

2015

Tested Model	BMW X1 sDrive18d, LHD
Body Type	- 5 door SUV
Year Of Publication	2015
Kerb Weight	1320kg
VIN From Which Rating Applies	- all X1s and X2s
Class	Small Off-Road

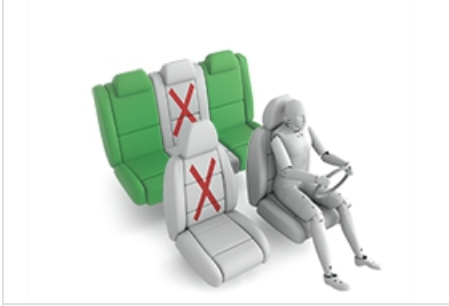
BeSafe iZi Kid X3 ISOFix (ISOFIX)

■ Infants and toddlers up to 18 kg

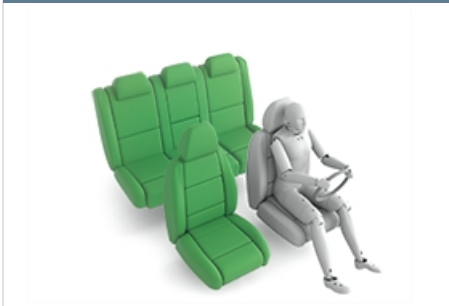
Britax Römer King Plus (Belt)

■ Toddlers from 9 to 18 kg

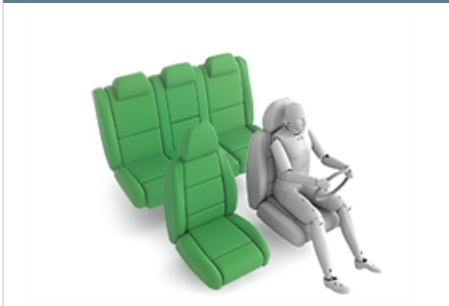
Britax Römer KidFix (Belt)

■ Toddlers over 18 kg
