Kia Niro
With Safety Pack

2022

Tested Model	Kia Niro
Safety pack	DriveWise
Body Type	- 5 door SUV
Year Of Publication	2022
Kerb Weight	1682kg
VIN From Which Rating Applies	- all Niros
Class	Small Off-Road

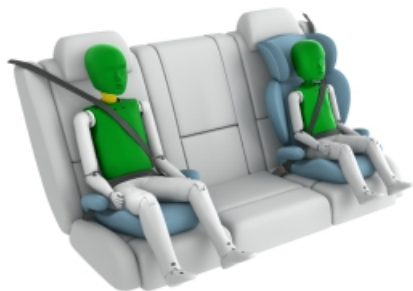
Frontal Impact

15.9 Pts

In the frontal offset test, protection of the 6 year dummy was good for all critical body areas and that of the 10 year dummy was good apart from adequate protection of the neck. In the side barrier test, dummy readings of acceleration in the head of the 10 year dummy revealed weak protection of that body region, probably related to bottoming-out of the airbag, but protection of all other critical areas was good for both the 6 and 10 year dummies. The front passenger airbag can be disabled to allow a rearward-facing child restraint to be used in that seating position. Clear information is provided to the driver regarding the status of the airbag and the system was rewarded. All of the restraint types for which the Niro is designed could be properly installed and accommodated.

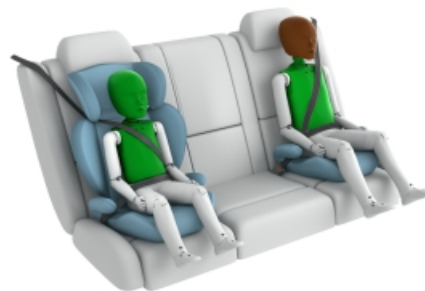
Lateral Impact

6.3 Pts
