Toyota Hilux
Standard Safety Equipment

2016

Tested Model	Toyota Hilux Double-Cab, 2.4 diesel 4x4, mid grade, LHD
Body Type	- Pickup
Year Of Publication	2016
Kerb Weight	2050kg
VIN From Which Rating Applies	- All Hilux double-cabs
Class	Pick-up

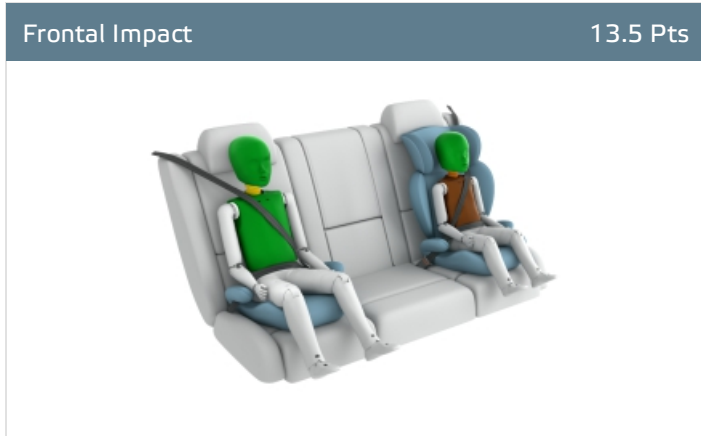
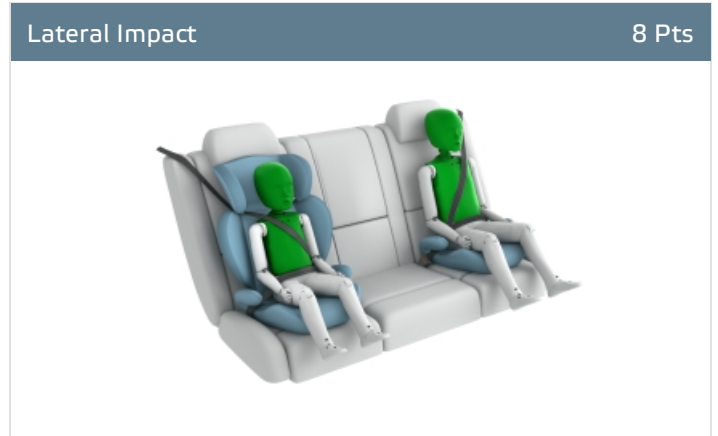
Crash Test Performance based on 6 & 10 year old children

21.5 Pts

Restraint for 6 year old child: *Toyota KidFix XP SICT*
 Restraint for 10 year old child: *Graco Junior*

In the frontal offset test, neck tension and chest deceleration revealed, respectively, marginal and weak protection for those body areas in the 6 year dummy. Protection of the 10 year dummy was good, apart from adequate protection of the neck, and, in the side impact was good for all critical body areas for both child dummies. The Hilux has an automatic system for disabling the front passenger airbag when, for example, a rearward-facing child restraint is used in that position. The system met Euro NCAP's requirements and was rewarded. All child restraints for which the Hilux is designed could be accommodated. However, the group 1 ISOFIX seat needed care to ensure correct installation and the rear centre seat is deemed unsuitable for child restraints by Toyota, although restraints could be properly installed there.
