MG ZS
Standard Safety Equipment

2017

Tested Model	MG ZS
Body Type	- 5 door SUV
Year Of Publication	2017
Kerb Weight	1204kg
VIN From Which Rating Applies	- all ZSs
Class	Small Family Car

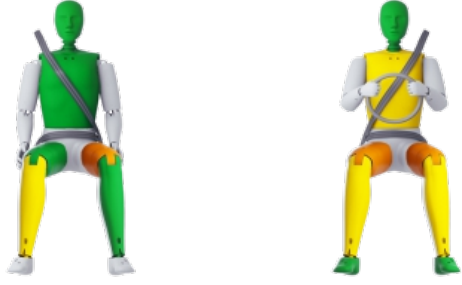
Frontal Offset Deformable Barrier 6.1 Pts

The passenger compartment of the ZS remained stable in the frontal offset test. Dummy readings indicated good protection of the knees and femurs of the driver and passenger but structures in the dashboard were thought to present a risk to occupants of different sizes and to those sat in different positions. In the full-width rigid barrier test, readings of chest compression in the rear passenger dummy indicated poor protection for this part of the body and protection of the head was rated as marginal, based on measured decelerations. In both the side barrier test and the more severe side pole impact, protection of all critical body areas was good and the ZS scored maximum points in these tests. Tests on the front seats and head restraints demonstrated marginal protection against whiplash injuries in the event of a rear-end collision. A geometric assessment of the rear seats also indicated marginal whiplash protection.

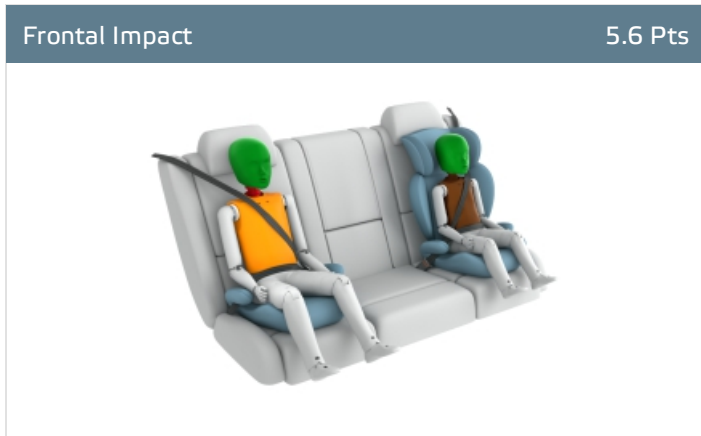
Crash Test Performance based on 6 & 10 year old children

Restraint for 6 year old child: *Britax Römer Kidfix XP*
 Restraint for 10 year old child: *Graco Junior III*

In the frontal offset test, protection of the neck of the 10 year dummy was rated as poor, based on measured values of tensile forces. Protection of the chest was marginal. For the 6 year dummy, protection of the chest and neck was weak, based on decelerations and tensile forces. In the side barrier test, the head of the 10 year dummy 'bottomed out' the airbag and injury criteria indicated poor protection for this part of the body. The front passenger airbag can be disabled to allow a rearward-facing dummy to be used in that seating position. Clear information is provided to the driver regarding the status of the airbag and the system was rewarded. There was insufficient seatbelt length to install Universal restraints properly in the front passenger seat. The same was true for one Universal seat in the rear centre seat and one other was unstable when installed. Otherwise, restraints could be properly installed and accommodated.
