Volkswagen ID.3
Standard Safety Equipment

2020

SPECIFICATION

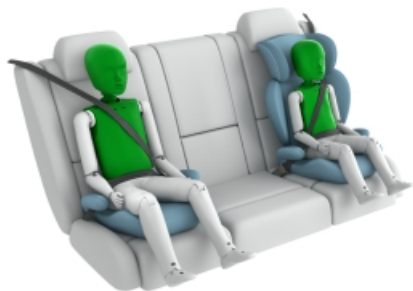
Frontal Impact

16 Pts

In both the frontal offset test and the side barrier impact, protection of all critical parts of the body was good for both child dummies, and the ID.3 scored maximum points in this part of the assessment. The front passenger airbag can be disabled to allow a rearward-facing child restraint to be used in that seating position. Clear information is provided to the driver regarding the status of the airbag and the system was rewarded. All of the restraints for which the ID.3 is designed could be properly installed and accommodated.

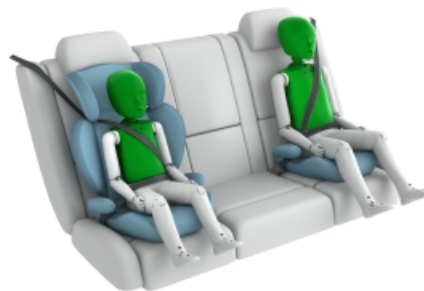
Lateral Impact

8 Pts

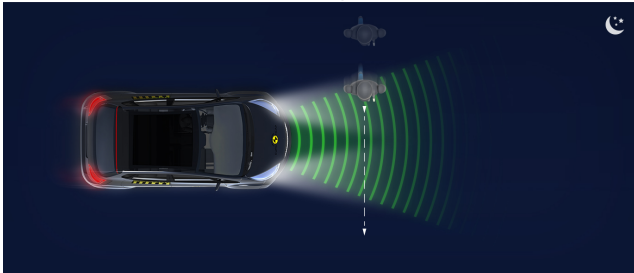
Adult crossing the road

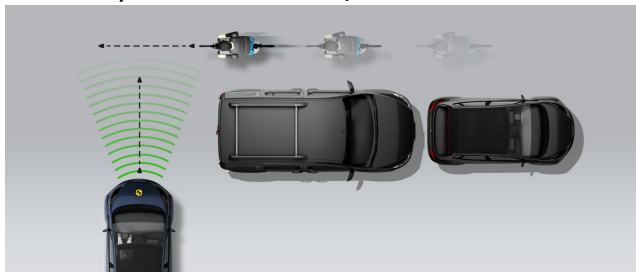
Cyclist from nearside, obstructed view

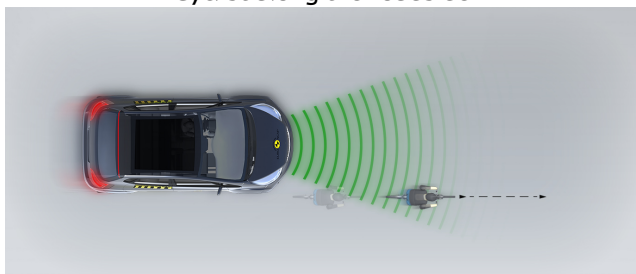
Cyclist along the roadside

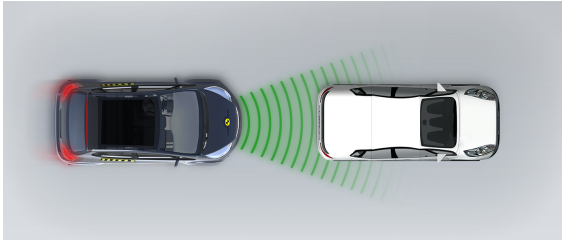
Approaching a stationary car

Autonomous emergency braking (AEB) is fitted as standard. The system performed well in tests of its detection and reaction to other vehicles, with impacts being avoided or mitigated in most cases. As well as a seatbelt reminder for front and rear seats, the ID.3 has a driver monitoring system which uses steering inputs to identify whether the driver is alert and focussed on the driving task or is impaired through fatigue or other factors. The system warns the driver if impaired driving is detected. The lane support system gently corrects the steering of the car if it is drifting out of lane and also intervenes more forcefully in some critical situations. A speed assistance system uses a camera and digital mapping to detect the local speed limit. This information is presented to the driver who can then confirm that the speed of the car is limited to the advised limit or can set the limiter manually.

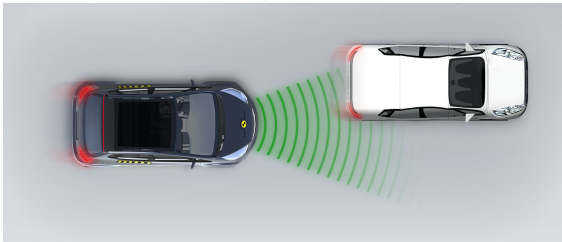
Approaching a slower moving car
