Mercedes-Benz Citan Tourer

Standard Safety Equipment

2022

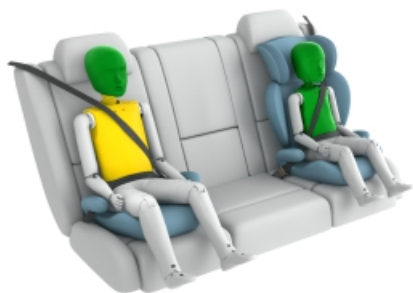
Frontal Impact

15.8 Pts

In the frontal offset test, protection of all critical body areas was good or adequate, for both the 6 and 10 year dummy. In the side barrier impact, protection of all body areas was good and maximum points were scored. The front passenger airbag is automatically disabled when a rearward-facing child restraint is put in that seating position. Tests showed that the system worked robustly and the system was rewarded. All of the child restraint types for which the car is designed could be properly installed and accommodated.

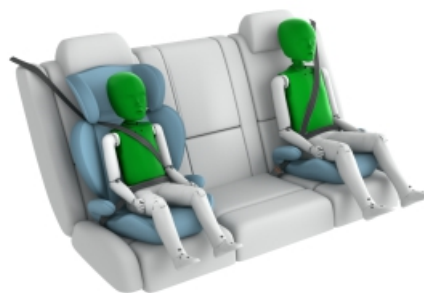
Lateral Impact

8 Pts
