**Mercedes-Benz C-Class Cabriolet**  
Standard Safety Equipment

2017

Tested Model	Mercedes-Benz C 220d Cabriolet, LHD
Body Type	- 2 door Cabriolet
Year Of Publication	2017
Kerb Weight	1745kg
VIN From Which Rating Applies	- all variants from WDD2054862F593831 except some 4x4
Class	Large Family Car

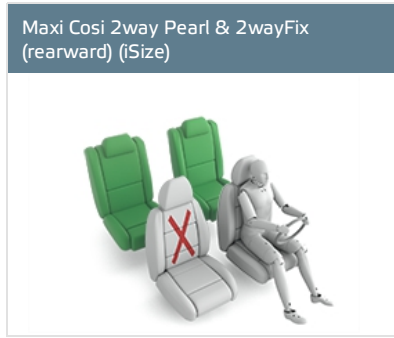
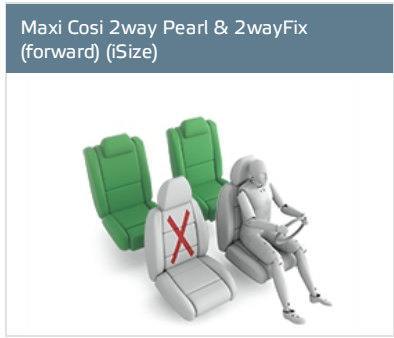
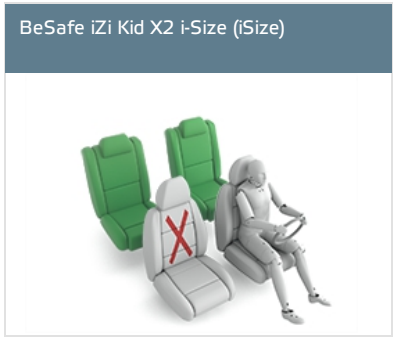
■ i-Size CRS

● Install without problem  
 ● Install with care  
 ● Safety critical problem  
 ✘ Installation not allowed
