VinFast VF8
Standard Safety Equipment

2023

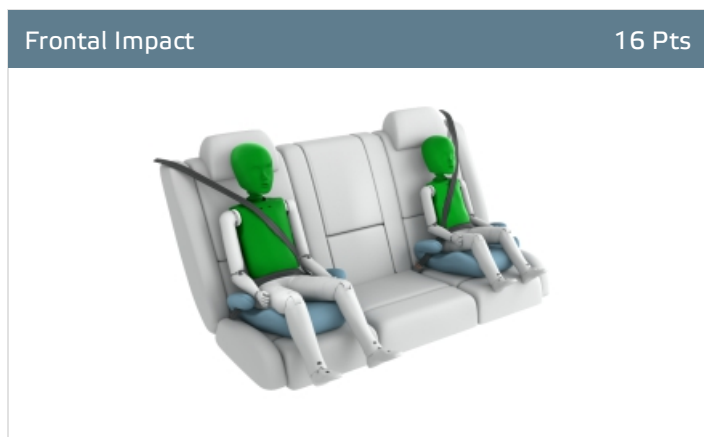
Crash Test Performance based on 6 & 10 year old children

24.0 / 24 Pts

Restraint for 6 year old child: *Britax Römer Kidfix i-Size*
 Restraint for 10 year old child: *Graco Booster Basic*

In both the frontal offset and side barrier tests, good protection was provided to all critical body areas for both child dummies, and the VinFast VF8 scored maximum points in this part of the assessment. The VinFast is equipped with automatic disabling of the front passenger airbag to allow a child restraint to be used in that seating position. VinFast demonstrated that the system operated robustly and the system was rewarded. The VF8 is equipped with a direct 'child presence detection' system, which issues a warning when it detects that a child or infant has been left in the car. However, VinFast could not demonstrate to Euro NCAP's satisfaction that all requirements were met, and the system was not rewarded. All of the child restraint types for which the VF8 is designed could be properly installed and accommodated in the car.
