**Ford Capri**  
Standard Safety Equipment

2024

## SPECIFICATION

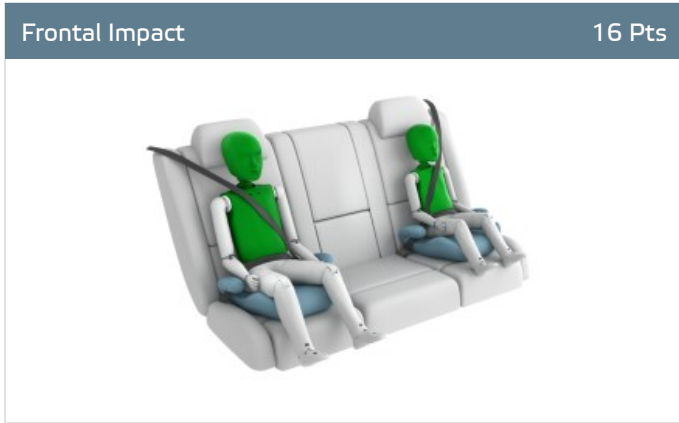
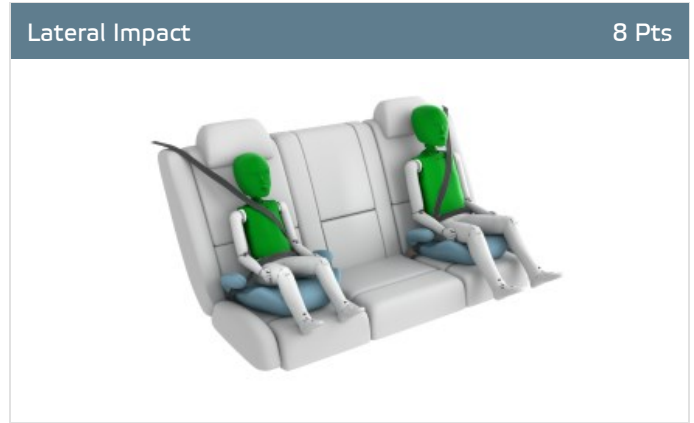
Crash Test Performance based on 6 & 10 year old children

Restraint for 6 year old child: *Britax Römer KIDFIX M i-SIZE*  
 Restraint for 10 year old child: *Britax Römer KIDFIX M i-SIZE (Booster only)*

In both the frontal offset and side barrier tests, the protection of all critical body areas of both child dummies was good, and the Capri scored full points. The front passenger airbag can be disabled to allow a rearward-facing child restraint to be used in that seating position. Clear information is provided to the driver regarding the status of the airbag and the system was rewarded. The car is equipped with an indirect 'child presence detection' system, which issues a warning when it recognises that a child or infant may have been left in the car. All of the child restraint types for which the Capri is designed could be properly installed and accommodated in the car.
