Ford Tourneo Courier
Standard Safety Equipment

2024

Adult Occupant

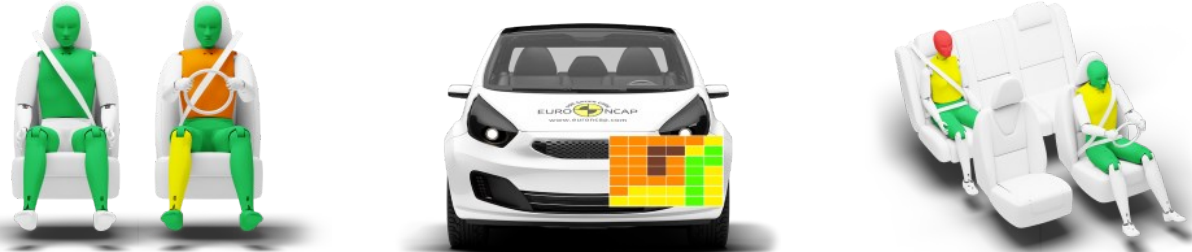
Frontal Impact 3.6 / 16 Pts

Mobile Progressive Deformable Barrier Full Width Rigid Barrier

The passenger compartment of the Ford Tourneo Courier remained stable in the frontal offset test. Dummy readings indicated good protection of the knees and femurs of both the driver and passenger. Ford demonstrated that a similar level of protection would be provided to the knees and femurs of occupants of different sizes and to those sitting in different positions. Based on dummy readings of compression, protection of the driver's chest was rated as marginal. Protection was good for all critical body areas of the front passenger. Analysis of the deceleration of the impact trolley during the test, and analysis of the deformable barrier after the test, revealed that the Ford Tourneo Courier would be a somewhat aggressive impact partner in a frontal collision. In the full-width rigid barrier test, protection of the rear passenger's head was rated as poor, based on dummy readings of deceleration, and the car scored no points for this test. In the side barrier test, protection was good for all critical body areas, and maximum points were scored. In the more severe side pole impact, protection the chest was adequate and that of other body areas was good. Control of excursion (the extent to which a body is thrown to the other side of the vehicle when it is hit from the far side) was found to be good. The Ford Tourneo Courier has a countermeasure to mitigate against occupant-to-occupant injuries in such impacts. The airbag performed well in Euro NCAP's tests with dummy readings indicating good protection for both the driver and passenger. Tests on the front seats and head restraints demonstrated good protection against whiplash injuries in the event of a rear-end collision. A geometric analysis of the rear seats also indicated good whiplash protection. The car has an advanced eCall system which alerts the emergency services in the event of a crash, and a system to prevent secondary impacts after the car has been in a collision. Ford demonstrated that the doors would be openable to allow occupants to escape in the event of vehicle submergence.

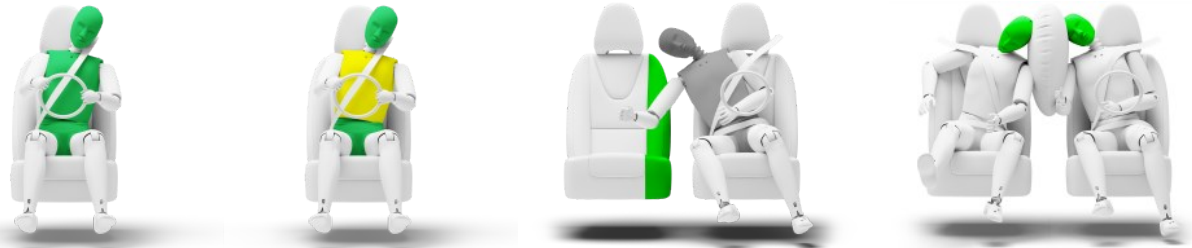
Lateral Impact 16.0 / 16 Pts

Side Mobile Barrier Side Pole Far-Side Excursion Occupant Interaction

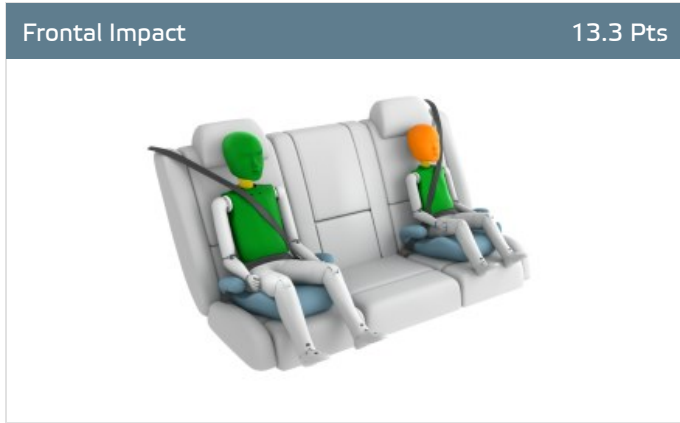
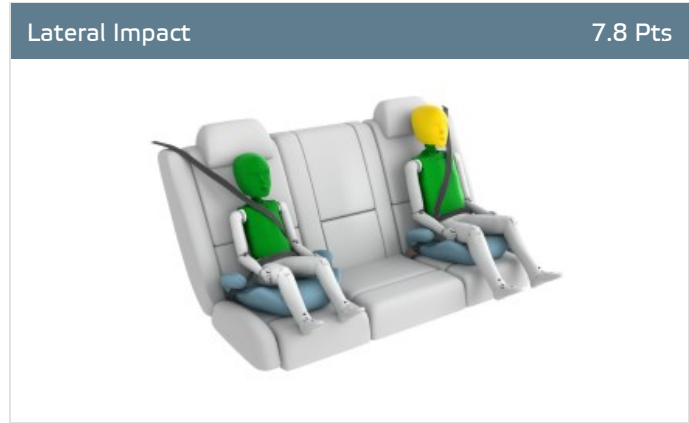
Crash Test Performance based on 6 & 10 year old children

21.1 / 24 Pts

Restraint for 6 year old child: *Britax Römer Kid Fix M iSize*
 Restraint for 10 year old child: *Britax Römer Kid Fix M iSize booster*

In both the frontal offset test, protection of the head of the 6 year dummy was rated as marginal, based on readings of decelerations. Otherwise, all critical parts of the body were well or adequately protected for the 6 and 10 year dummy in both the frontal offset and side barrier tests. The front passenger airbag can be disabled to allow a rearward-facing child restraint to be used in that seating position. Clear information is provided to the driver regarding the status of the airbag, and the system was rewarded. The Tourneo Courier is equipped with an indirect 'child presence detection' system, which issues a warning when it recognises that a child or infant may have been left in the car. All of the child restraint types for which the Ford Tourneo Courier is designed could be properly installed and accommodated in the car.
