**Volvo EX30**  
Standard Safety Equipment

2024

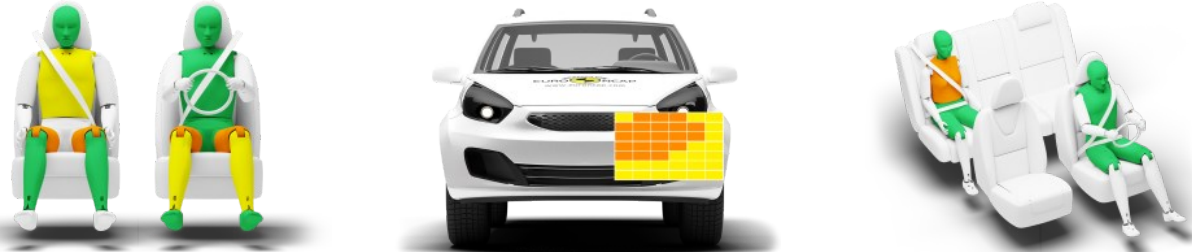
Frontal Impact 13.7 / 16 Pts

Mobile Progressive Deformable Barrier      Full Width Rigid Barrier

The passenger compartment of the Volvo EX30 remained stable in the frontal offset test. Dummy readings indicated good protection of the knees and femurs for the driver and front passenger. Volvo did not demonstrate that a similar level of protection would be provided to occupants of different sizes and to those sitting in different positions, and the car was penalised. Analysis of the deceleration of the impact trolley during the test, and analysis of the deformable barrier after the test, revealed that the Volvo EX30 would be a benign impact partner in a frontal collision. In the full-width rigid barrier test, protection of the chest of the rear passenger was rated as marginal, based on dummy readings of compression. Otherwise, protection was good for the driver and rear passenger. In the side barrier test, full points were scored, with good protection of all critical body regions. In the more severe side pole impact, protection of the chest was weak but that of other parts of the body was good. Control of excursion (the extent to which a body is thrown to the other side of the vehicle when it is hit from the far side) was found to be adequate. The Volvo EX30 has a countermeasure to mitigate against occupant-to-occupant injuries in such impacts. The airbag performed well in Euro NCAP's tests with dummy readings indicating good protection for both the driver and passenger. Tests on the front seats and head restraints demonstrated good protection against whiplash injuries in the event of a rear-end collision. A geometric analysis of the rear seats also indicated good whiplash protection. The car has an advanced eCall system which alerts the emergency services in the event of a crash, and a system to prevent secondary impacts after the car has been in a collision. Volvo demonstrated that the doors and windows would be openable to allow occupants to escape in the event of vehicle submergence.

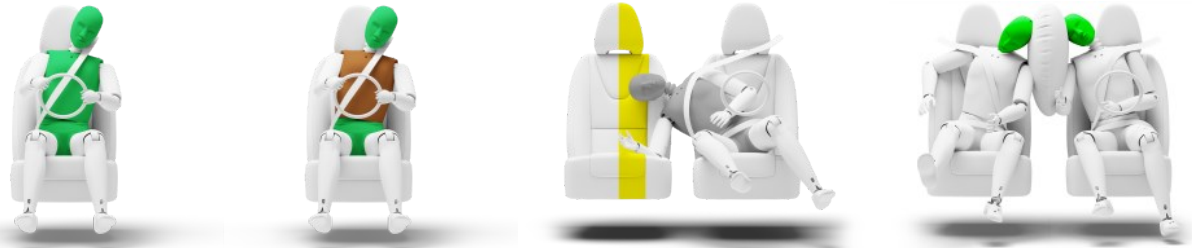
Lateral Impact 15.0 / 16 Pts

Side Mobile Barrier      Side Pole      Far-Side Excursion      Occupant Interaction
